# **Seismic Risk of Unreinforced Masonry Buildings in Nevada**

**Craig M. dePolo**

**Nevada Bureau of Mines and Geology**

**October 16, 2019**

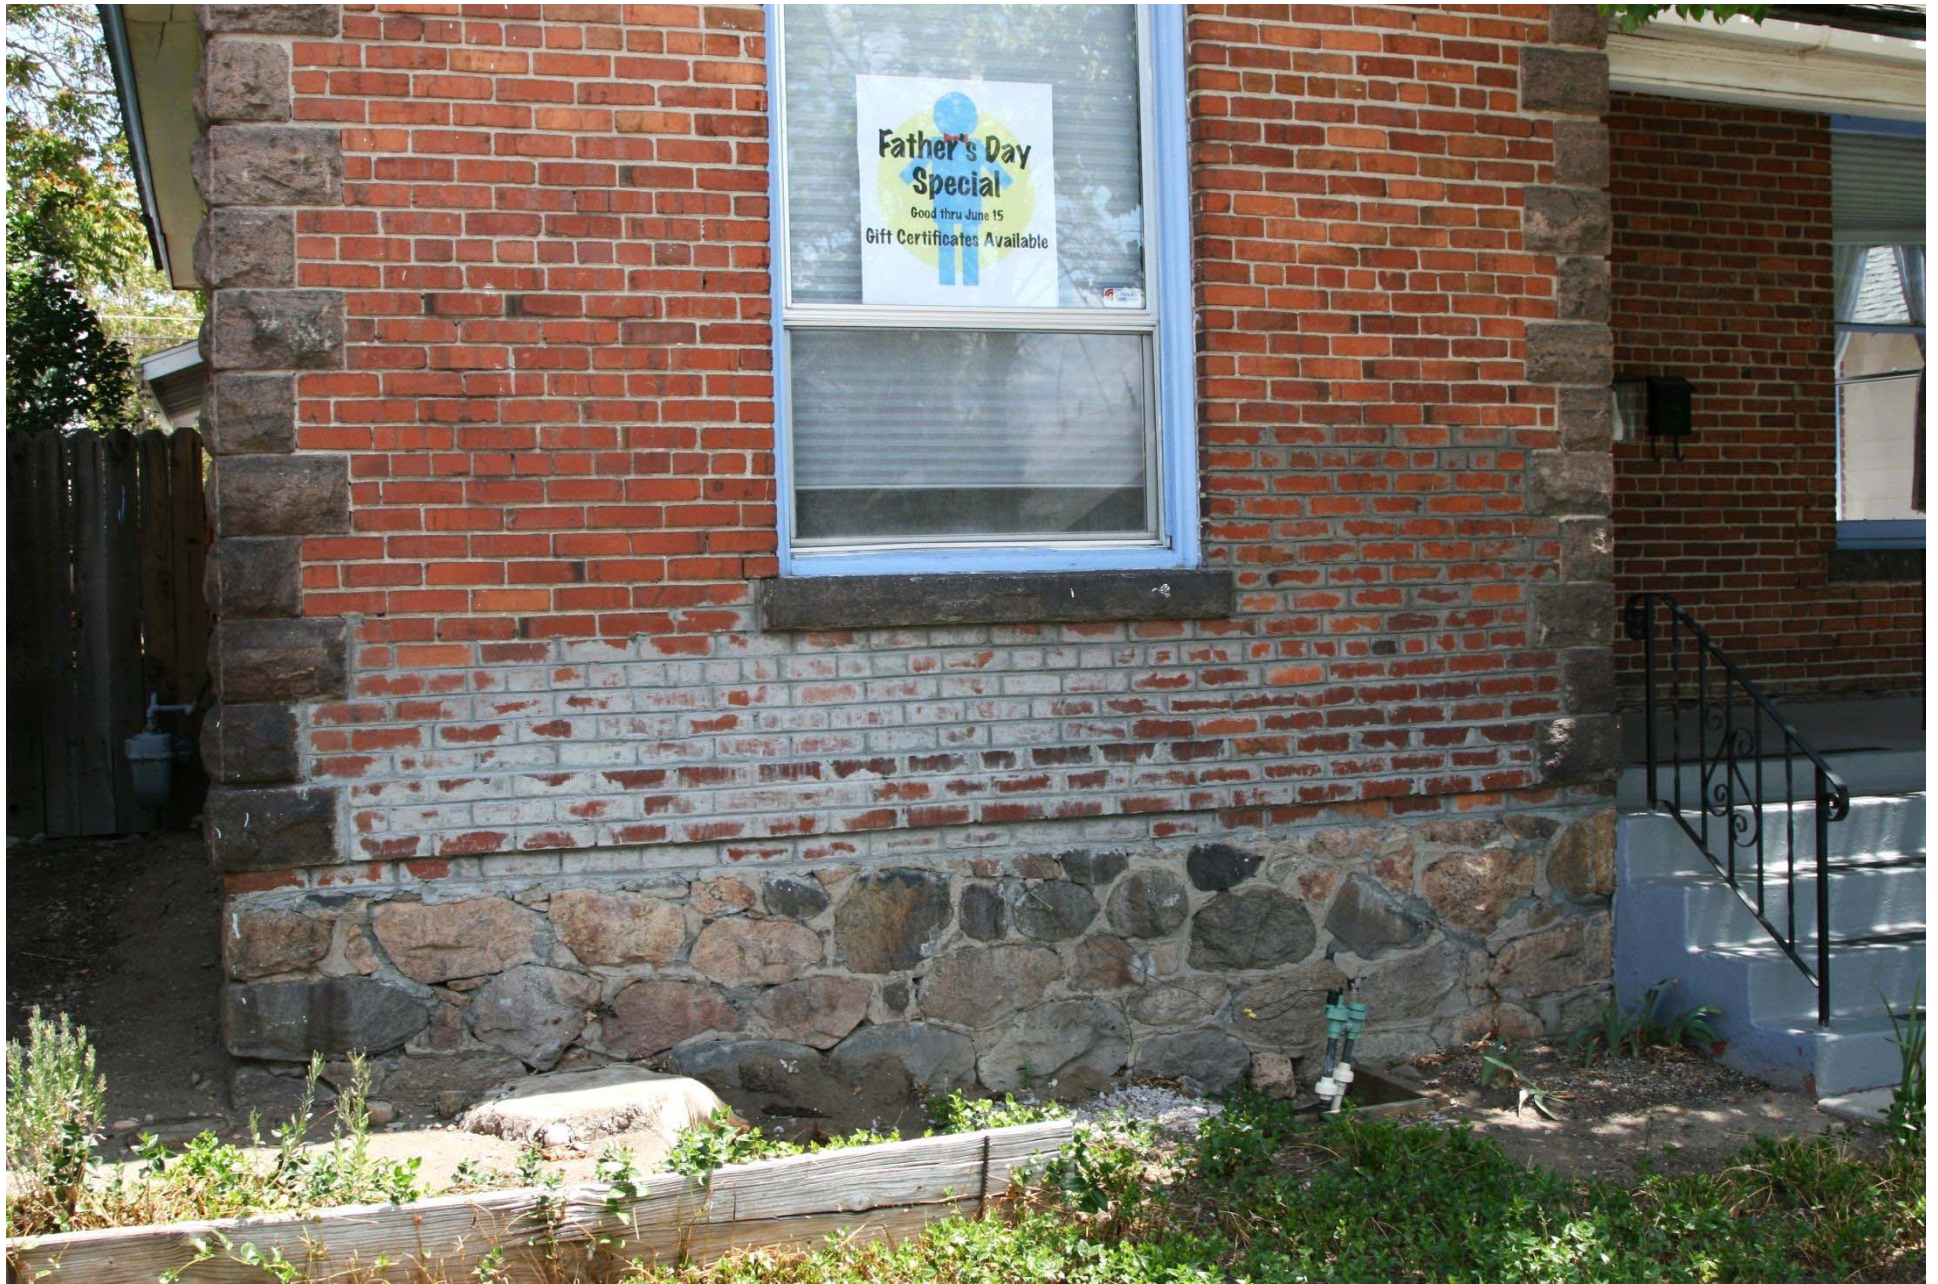
**Rock rubble foundation; every 8<sup>th</sup> brick course in on end to tie wall together**

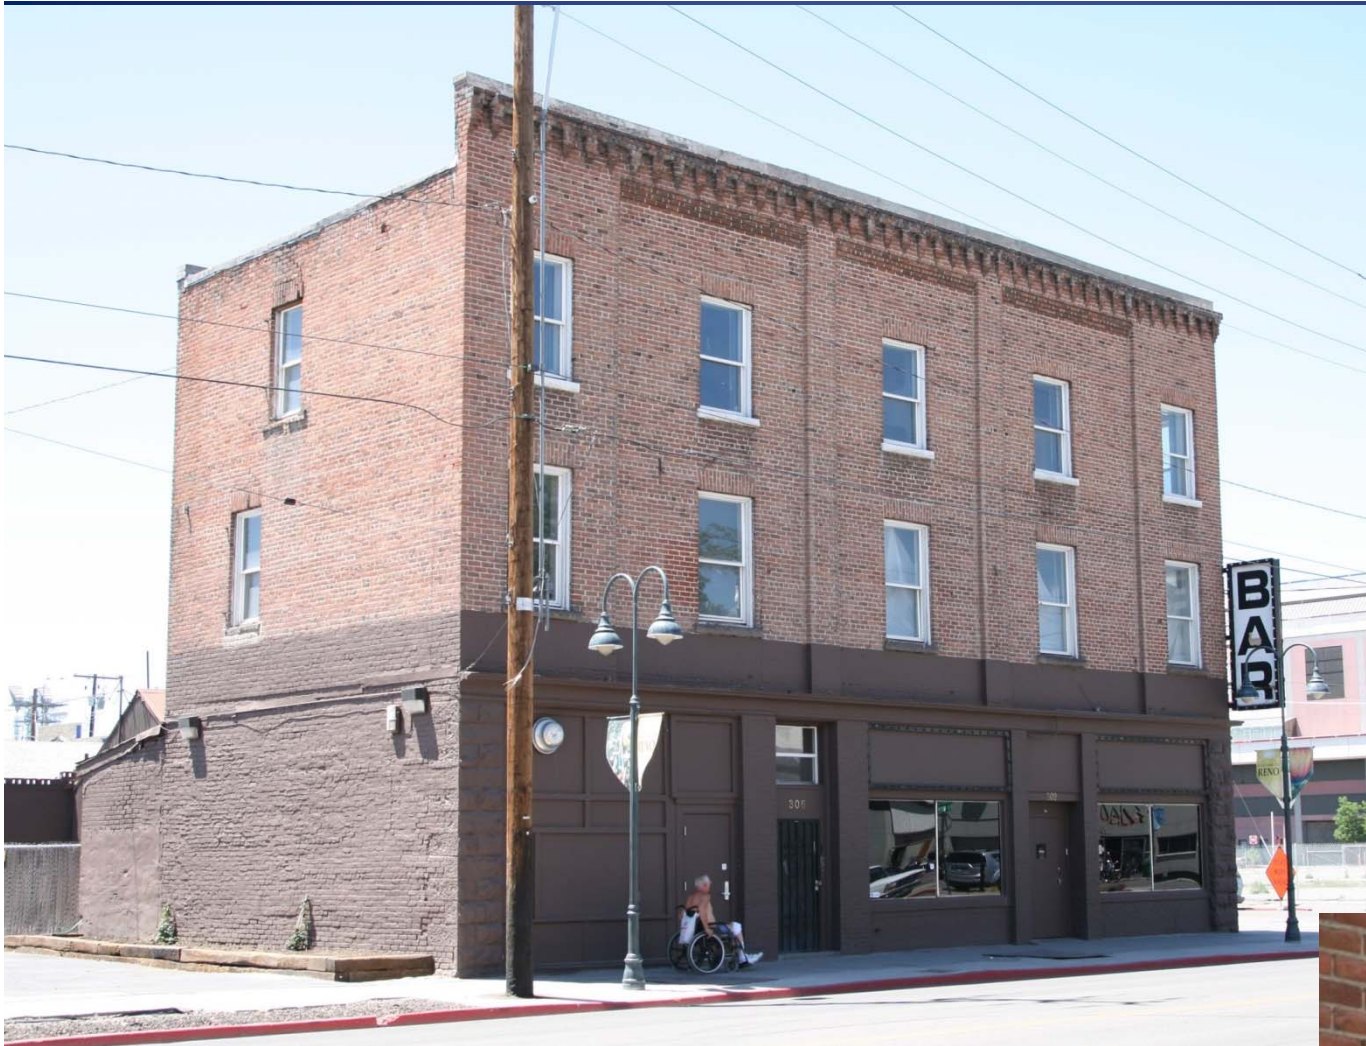
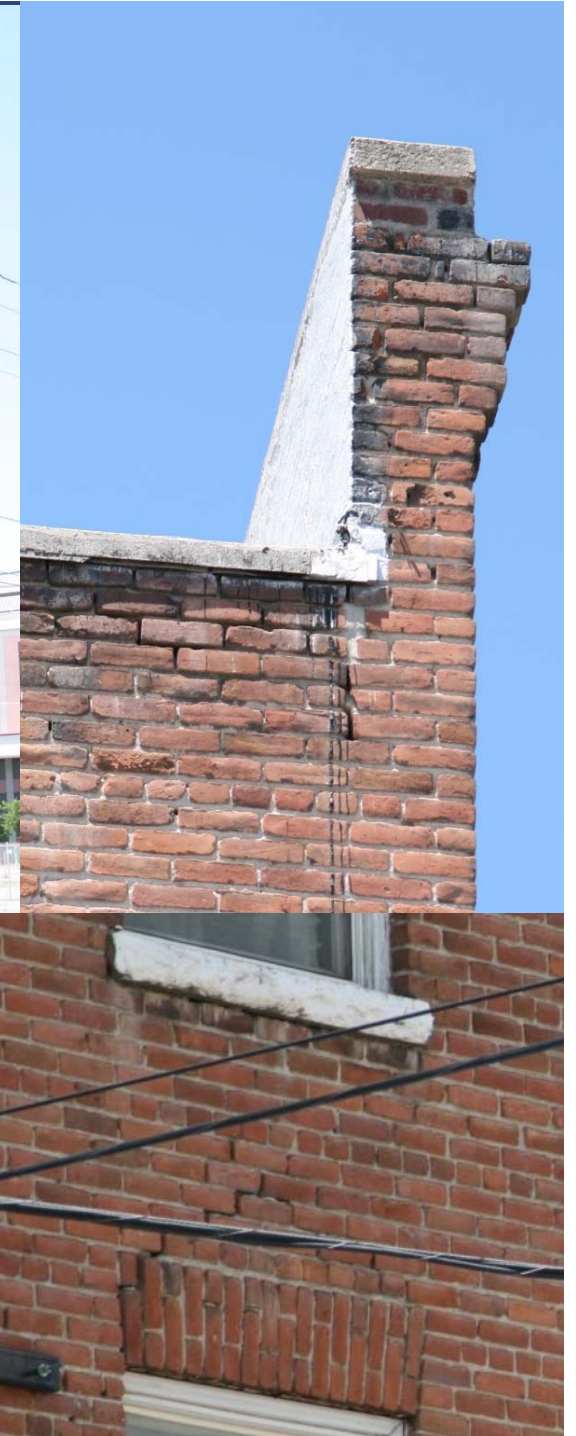
Three-story URM with parapet  
and some earthquake cracks;  
occupancy is variable

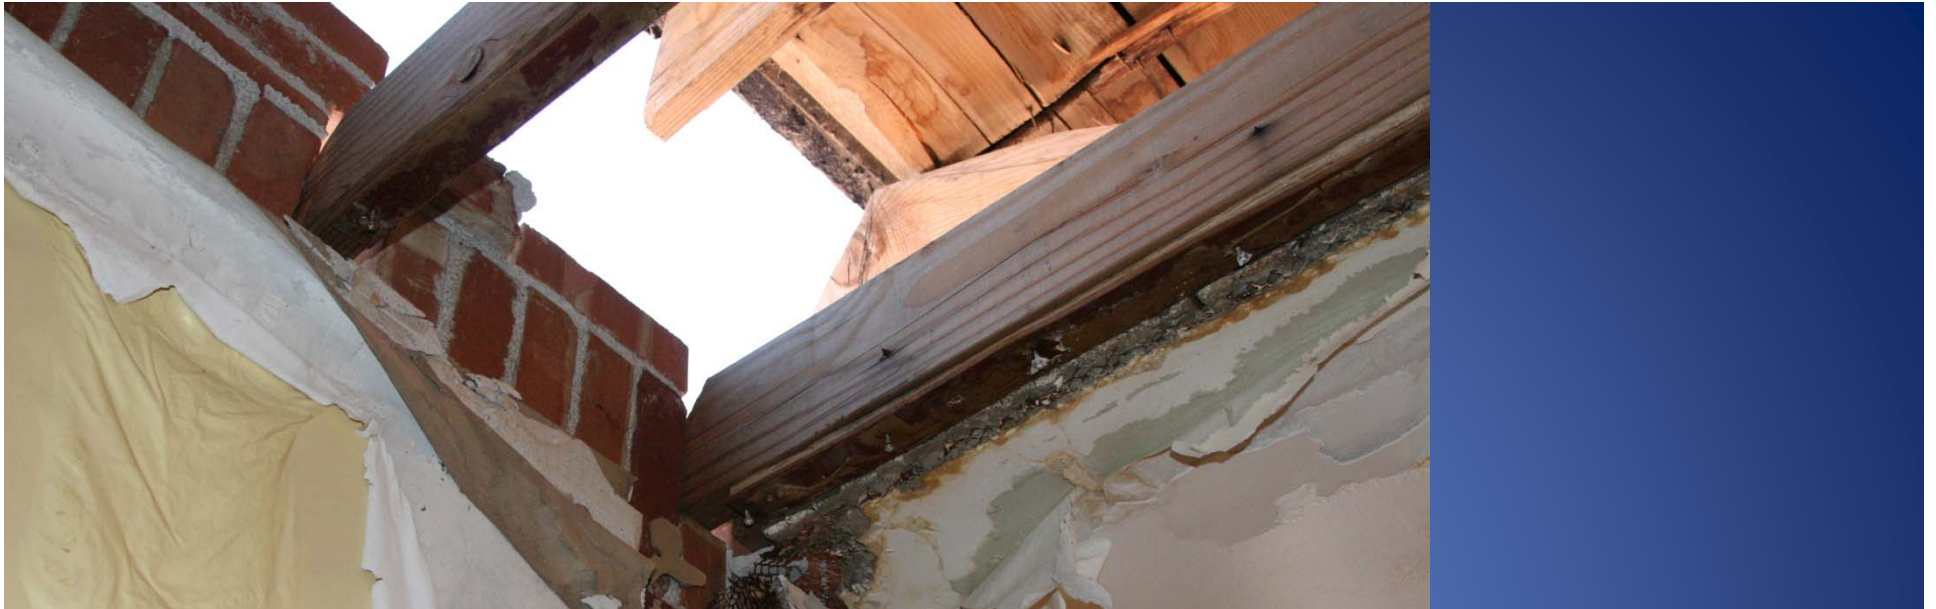
Ceiling joist pulling out of  
wall socket; note diagonal  
fire cut on end of beam

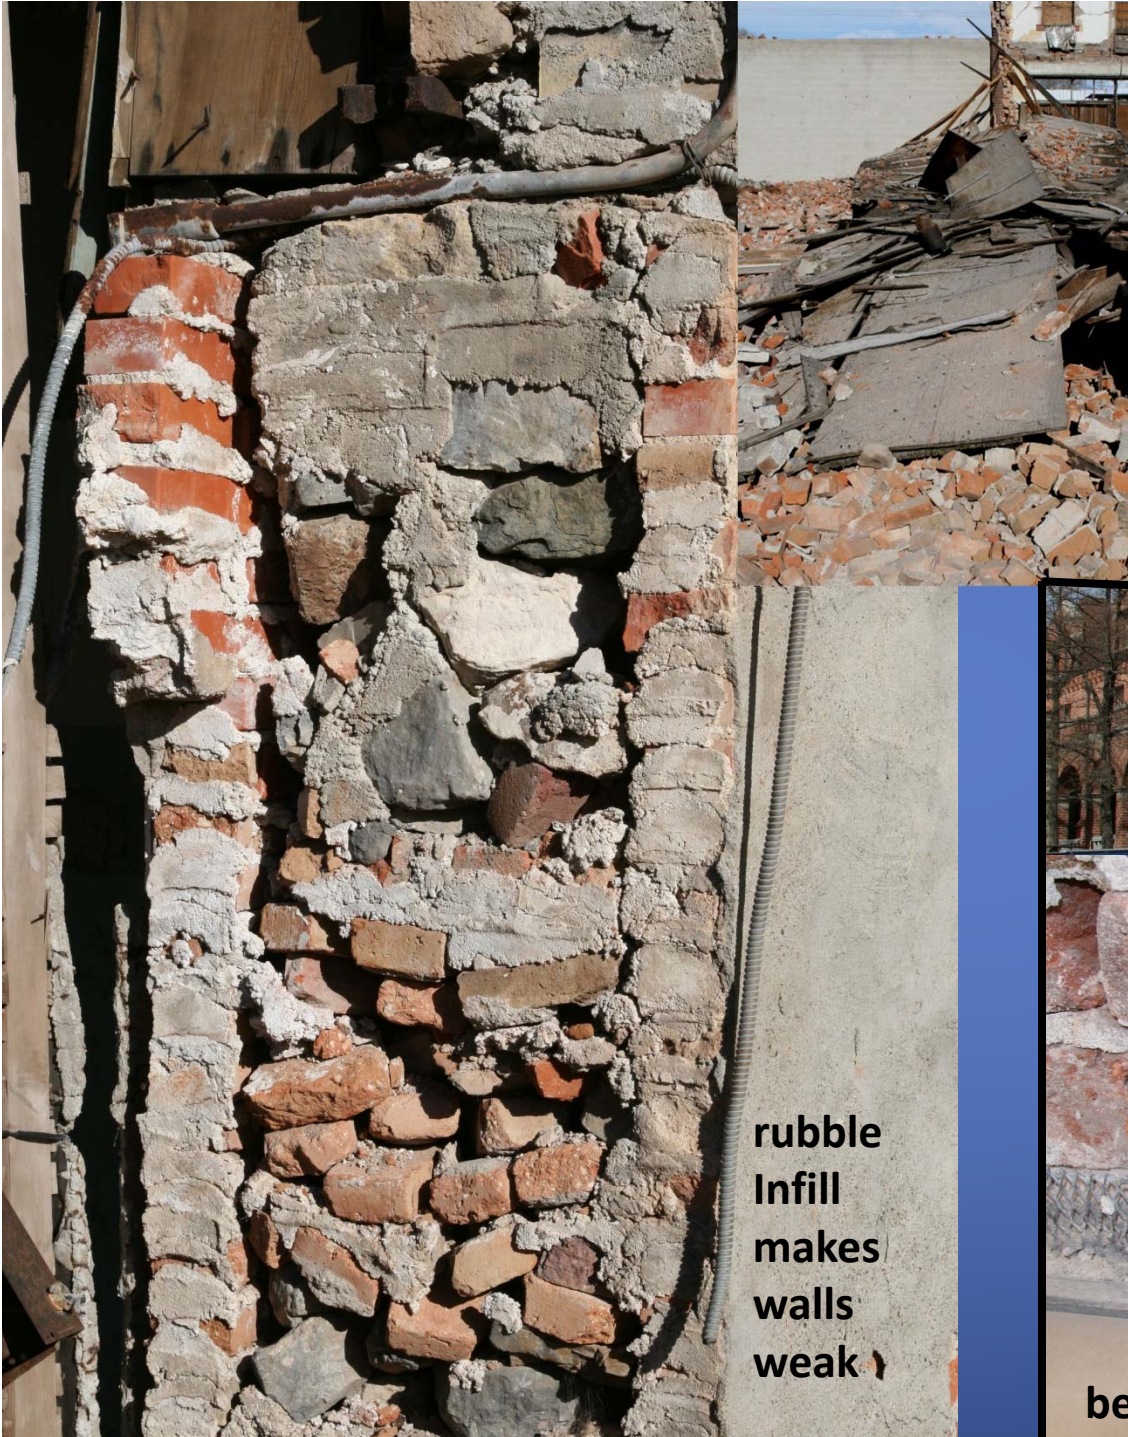
rubble  
Infill  
makes  
walls  
weak

**Below** – Lincoln Hall has an air gap  
between the interior wall that holds up  
the floors and the outside wall that  
holds up the roof

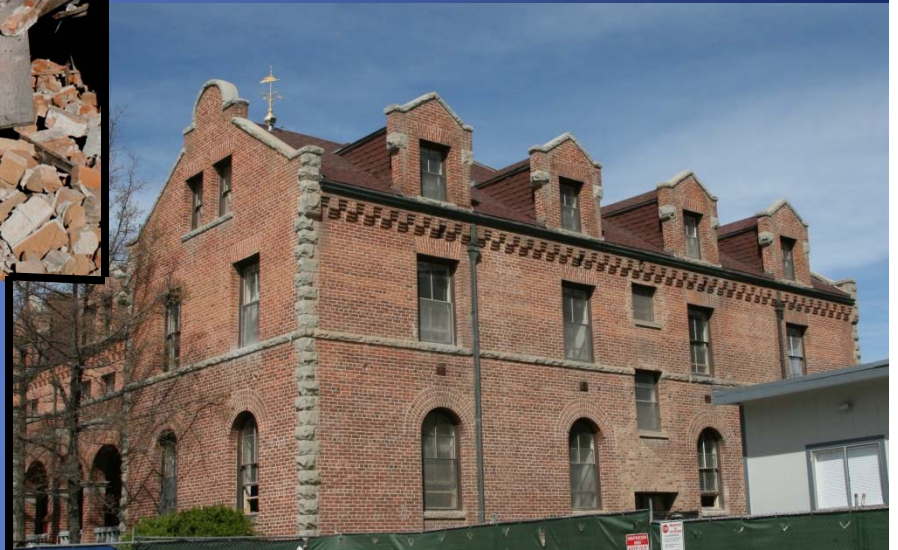
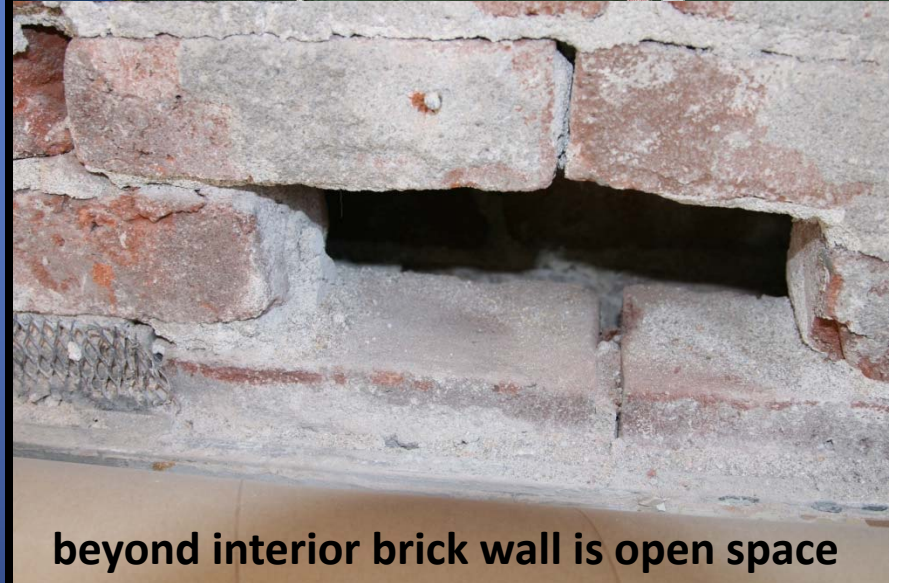
beyond interior brick wall is open space

Crowning bond beam failures

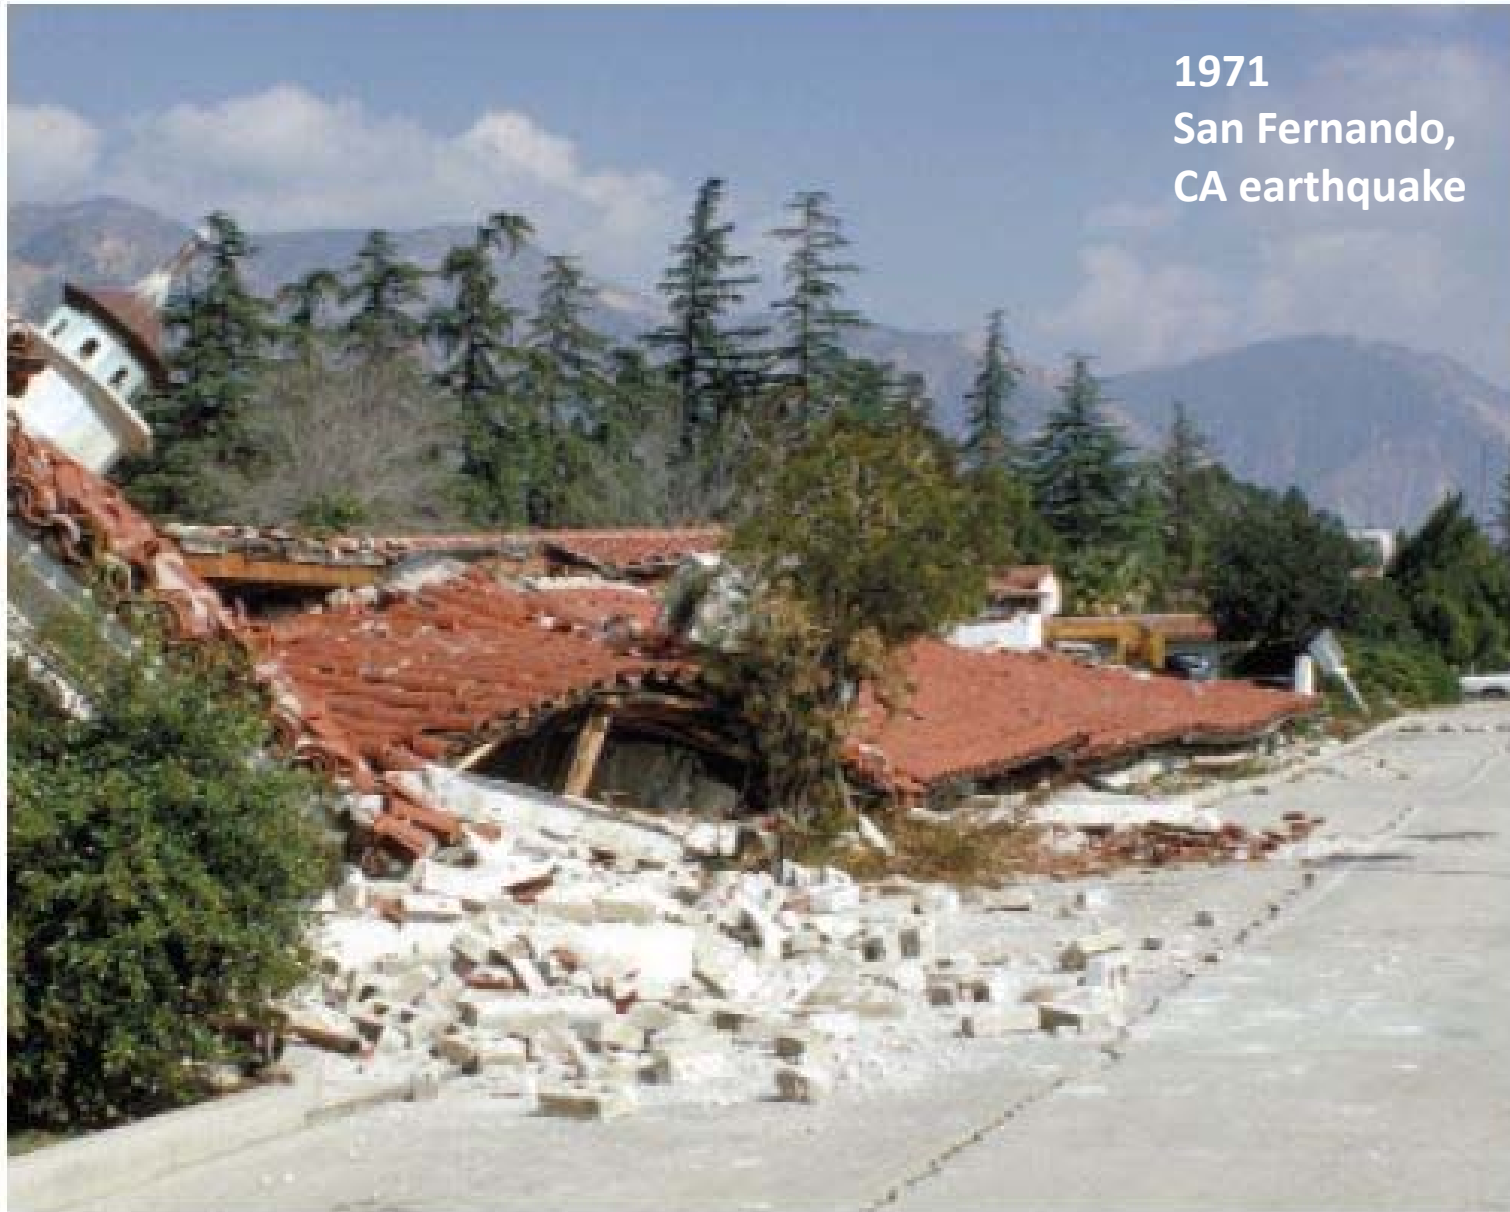
CMU – concrete masonry unit – *unreinforced* cinder block buildings

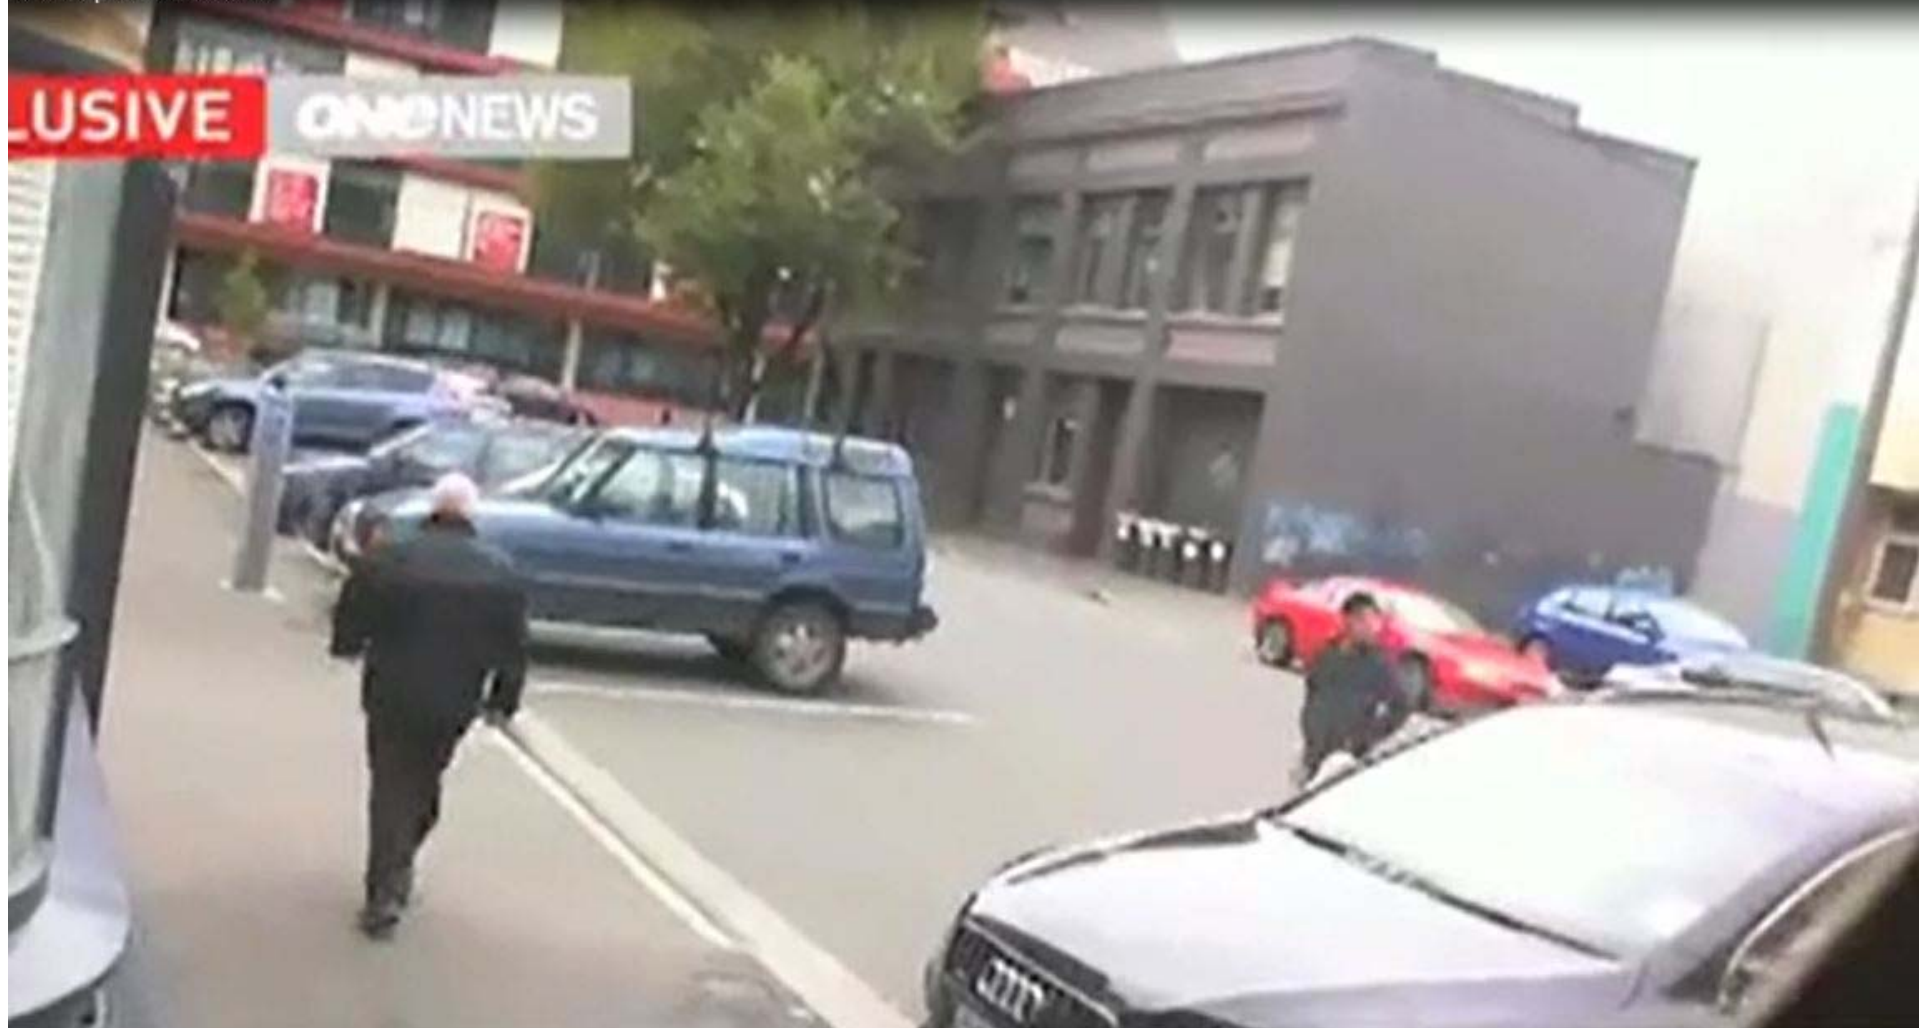
Brown URMB (upper right quarter) immediately before the earthquake

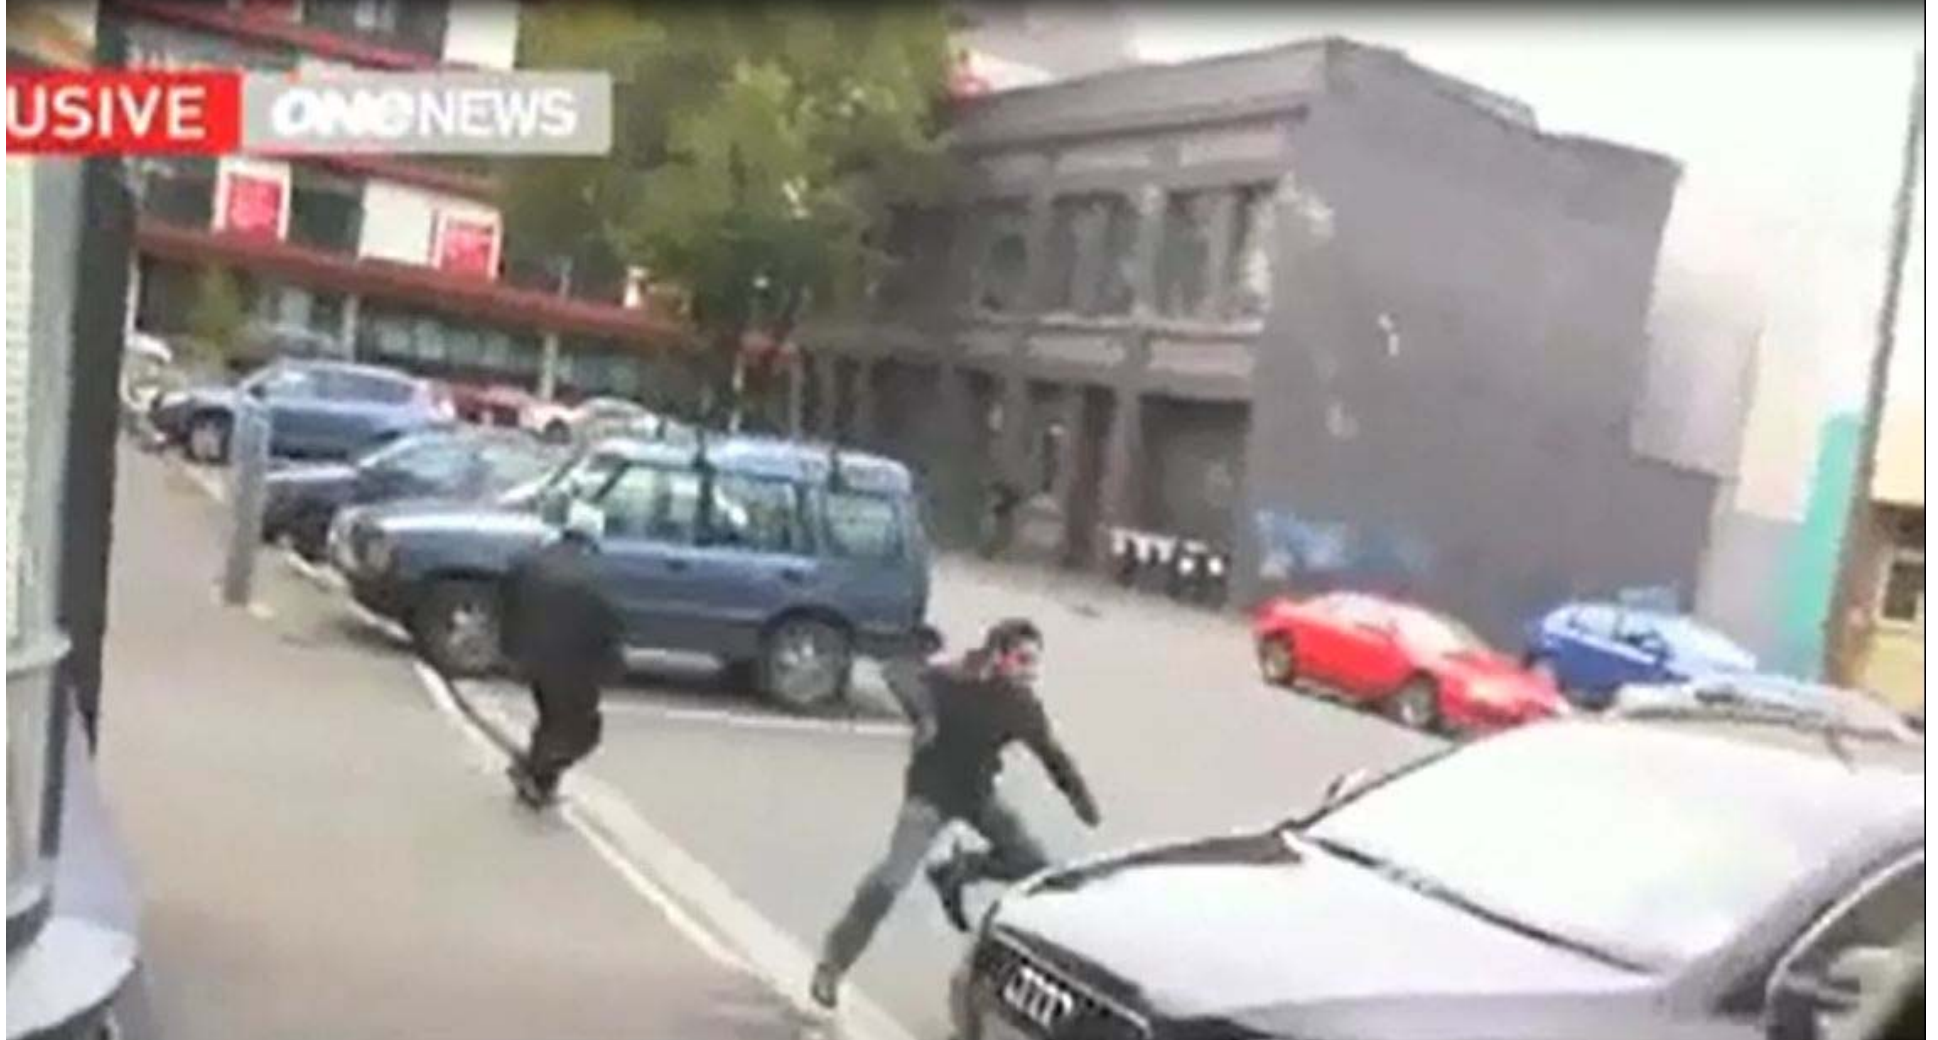
Near the beginning of the eq., people reacting, upper part of right-facing wall is starting to fall outwards from top. Some cracks are forming in this wall shown by dust.

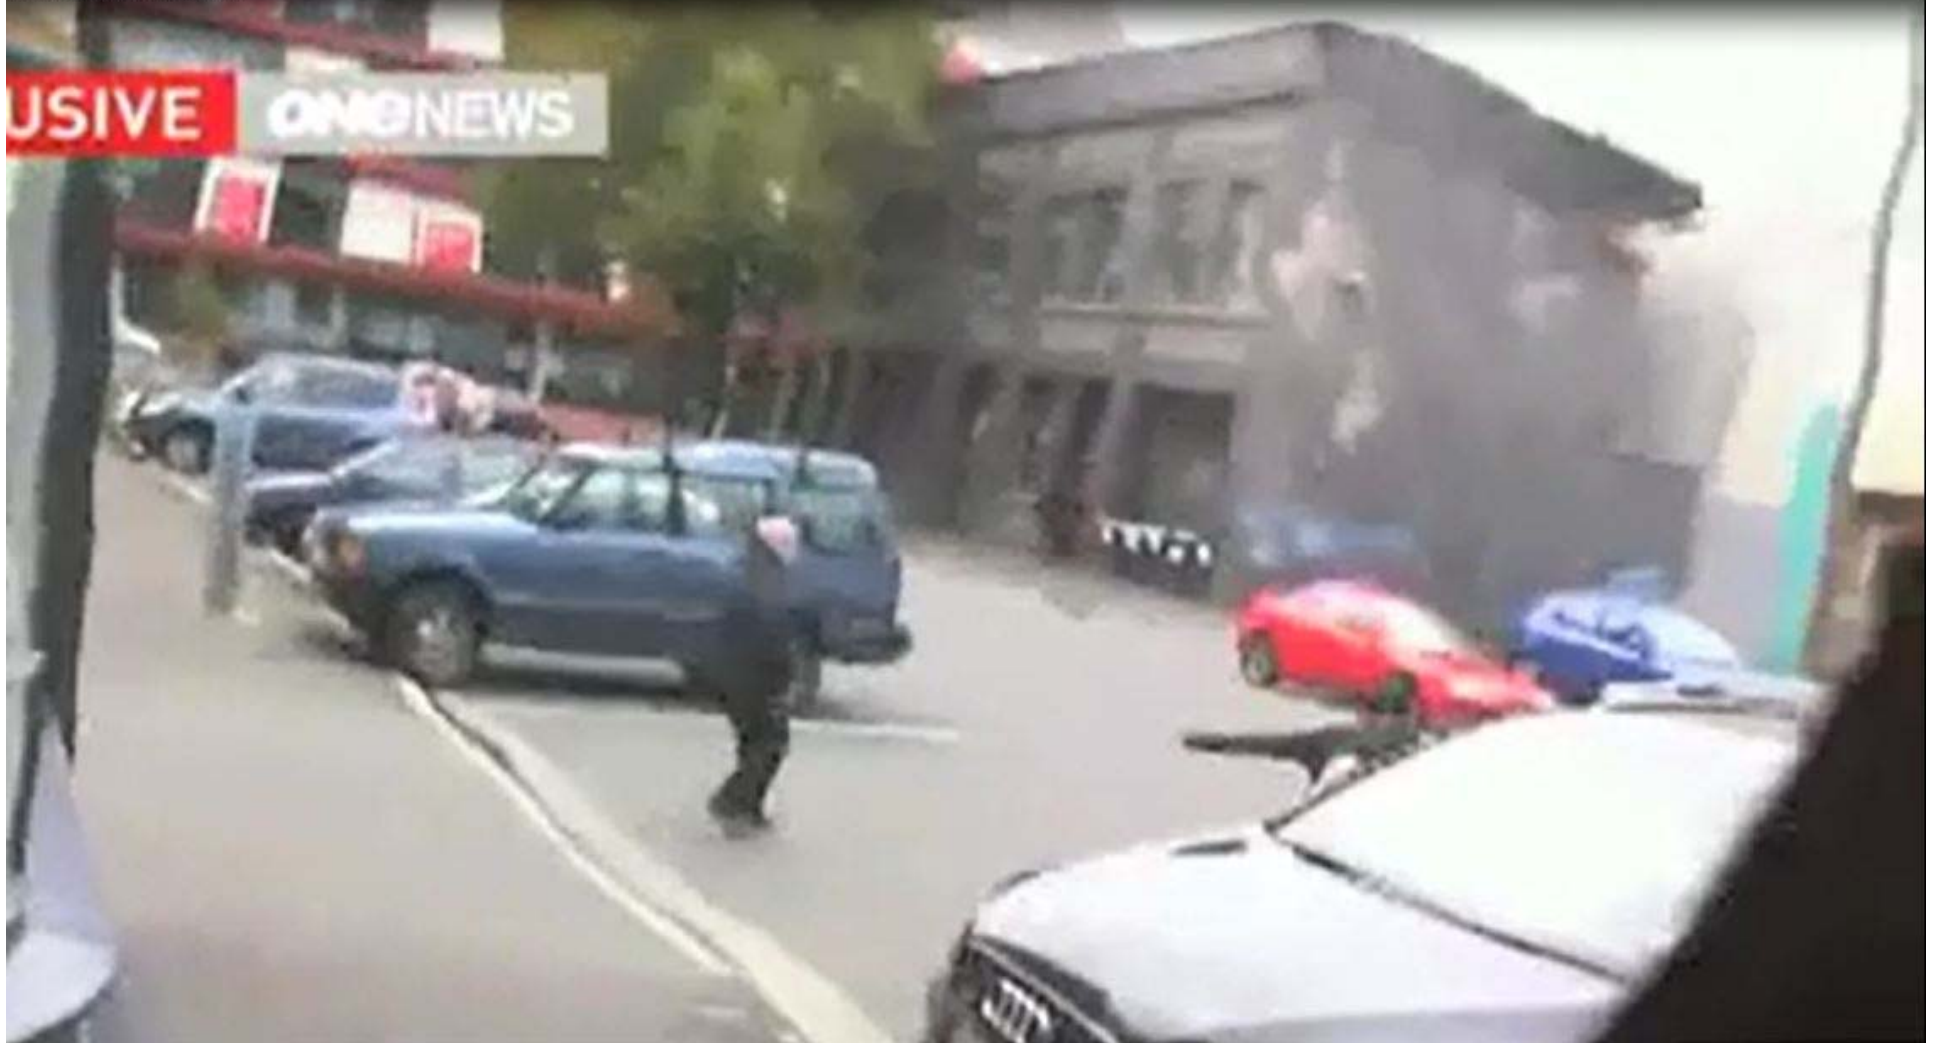
Upper part of right-facing wall has fallen out (above top ceiling joist) and is falling down the side of the building.

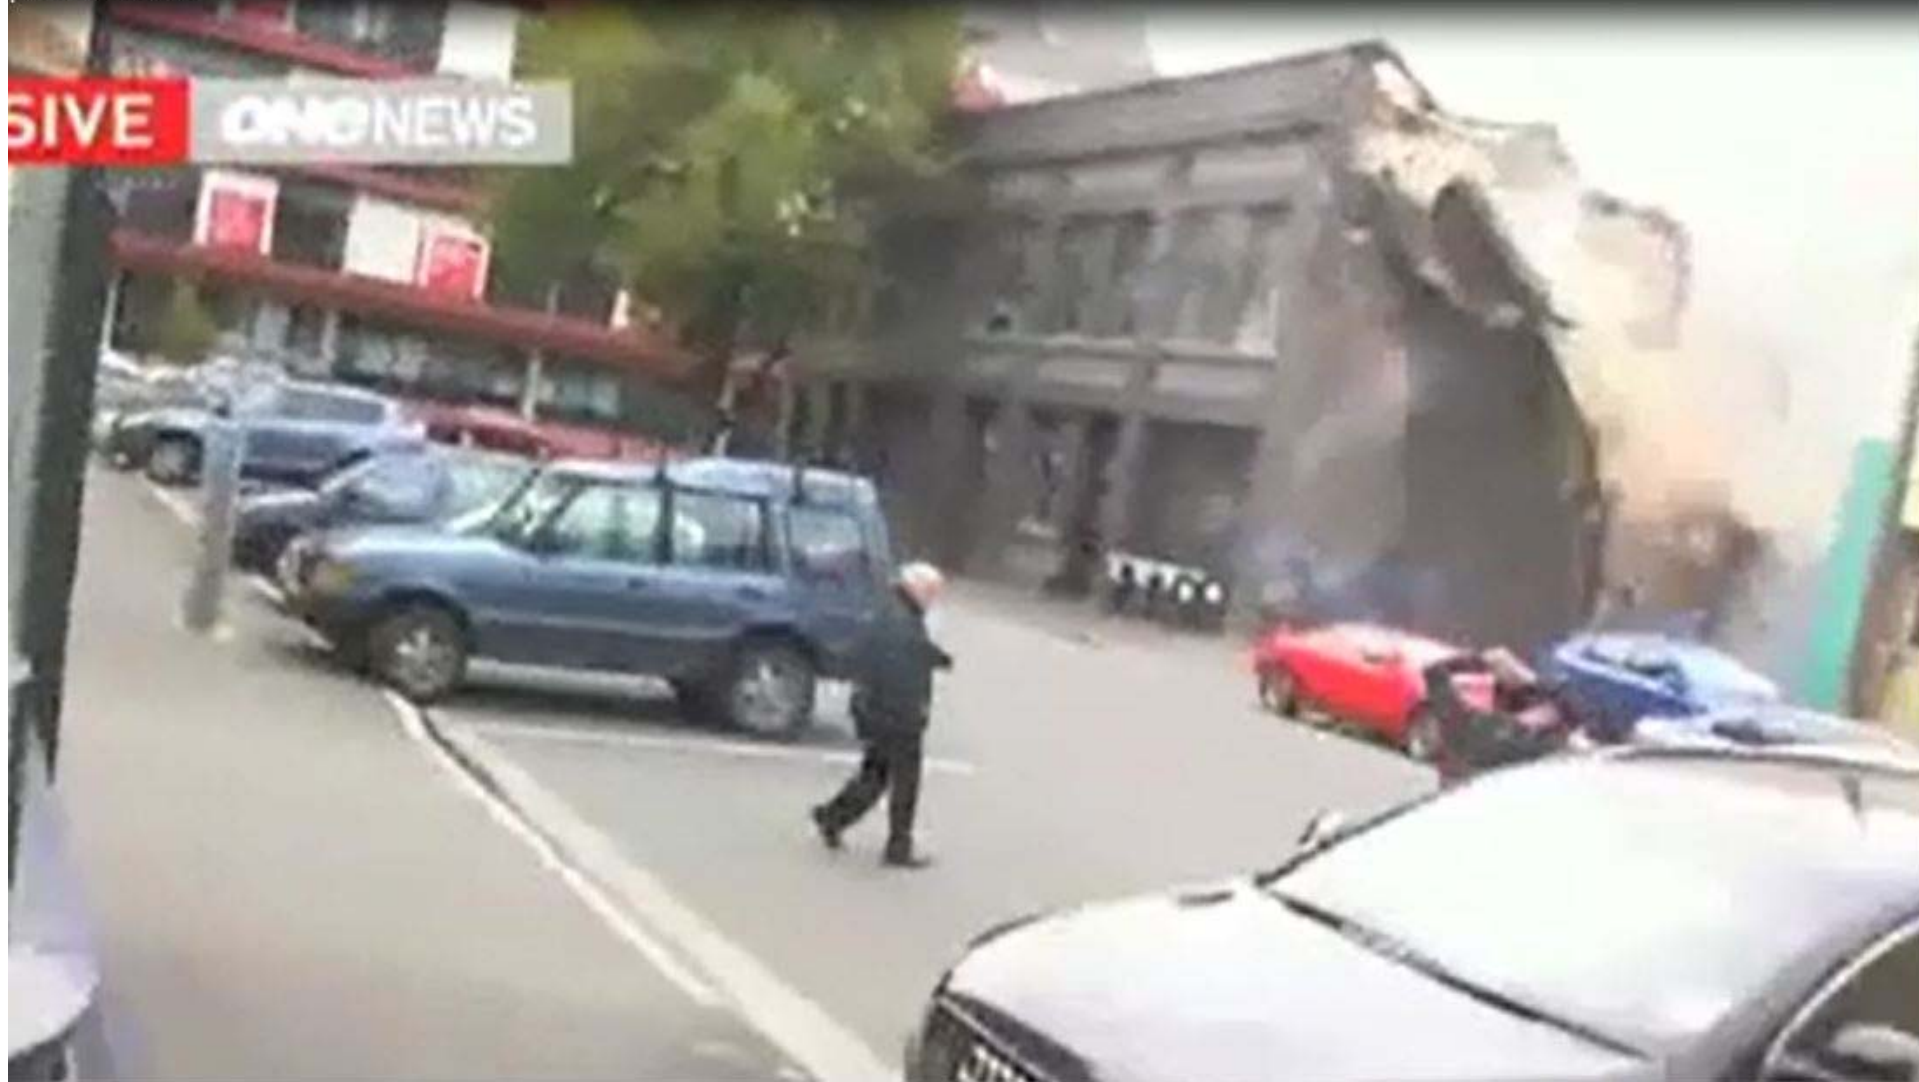
**A major portion of the right-facing wall is peeling off and falling next to the building. One man has hands on head in awe.**

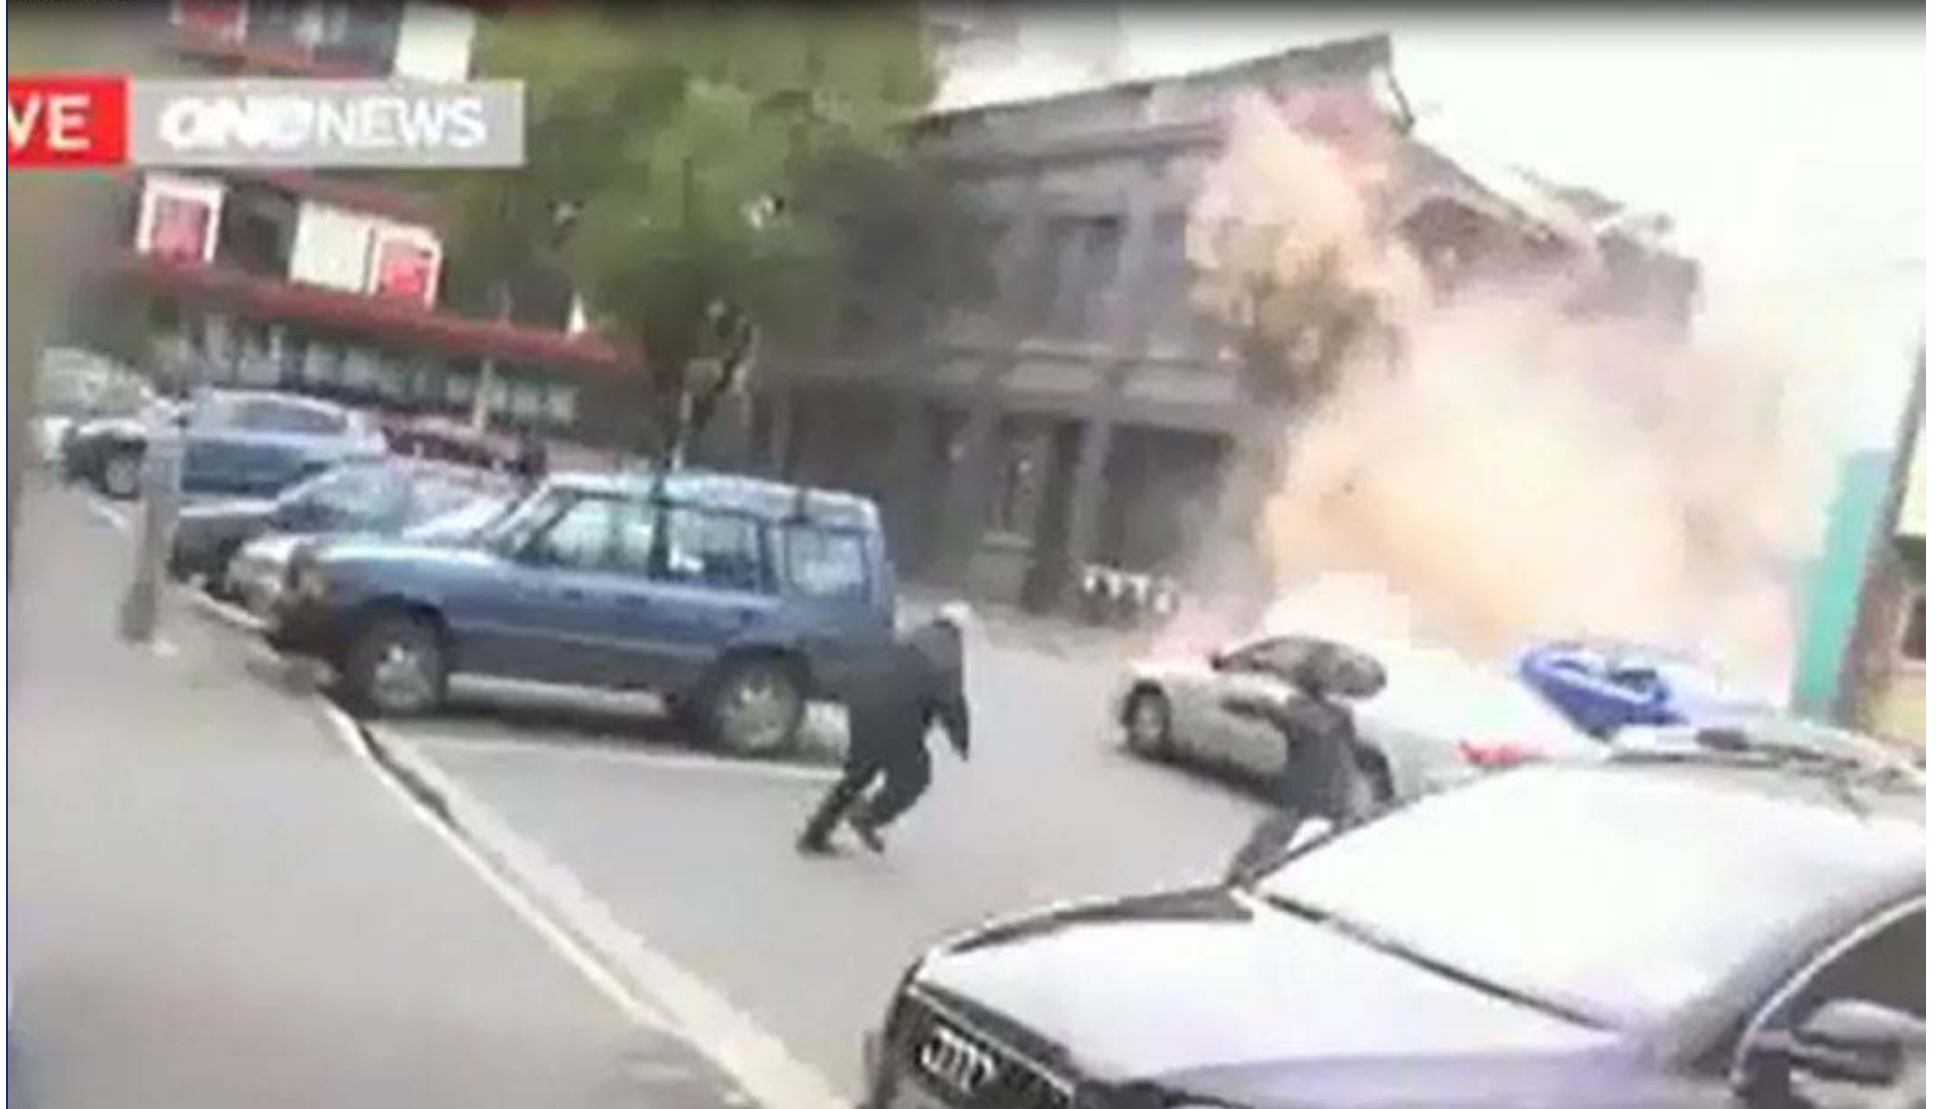
Large portion of the right-facing wall is falling on ground and dismembering. Dust rising from central part of the building indicates failure there.

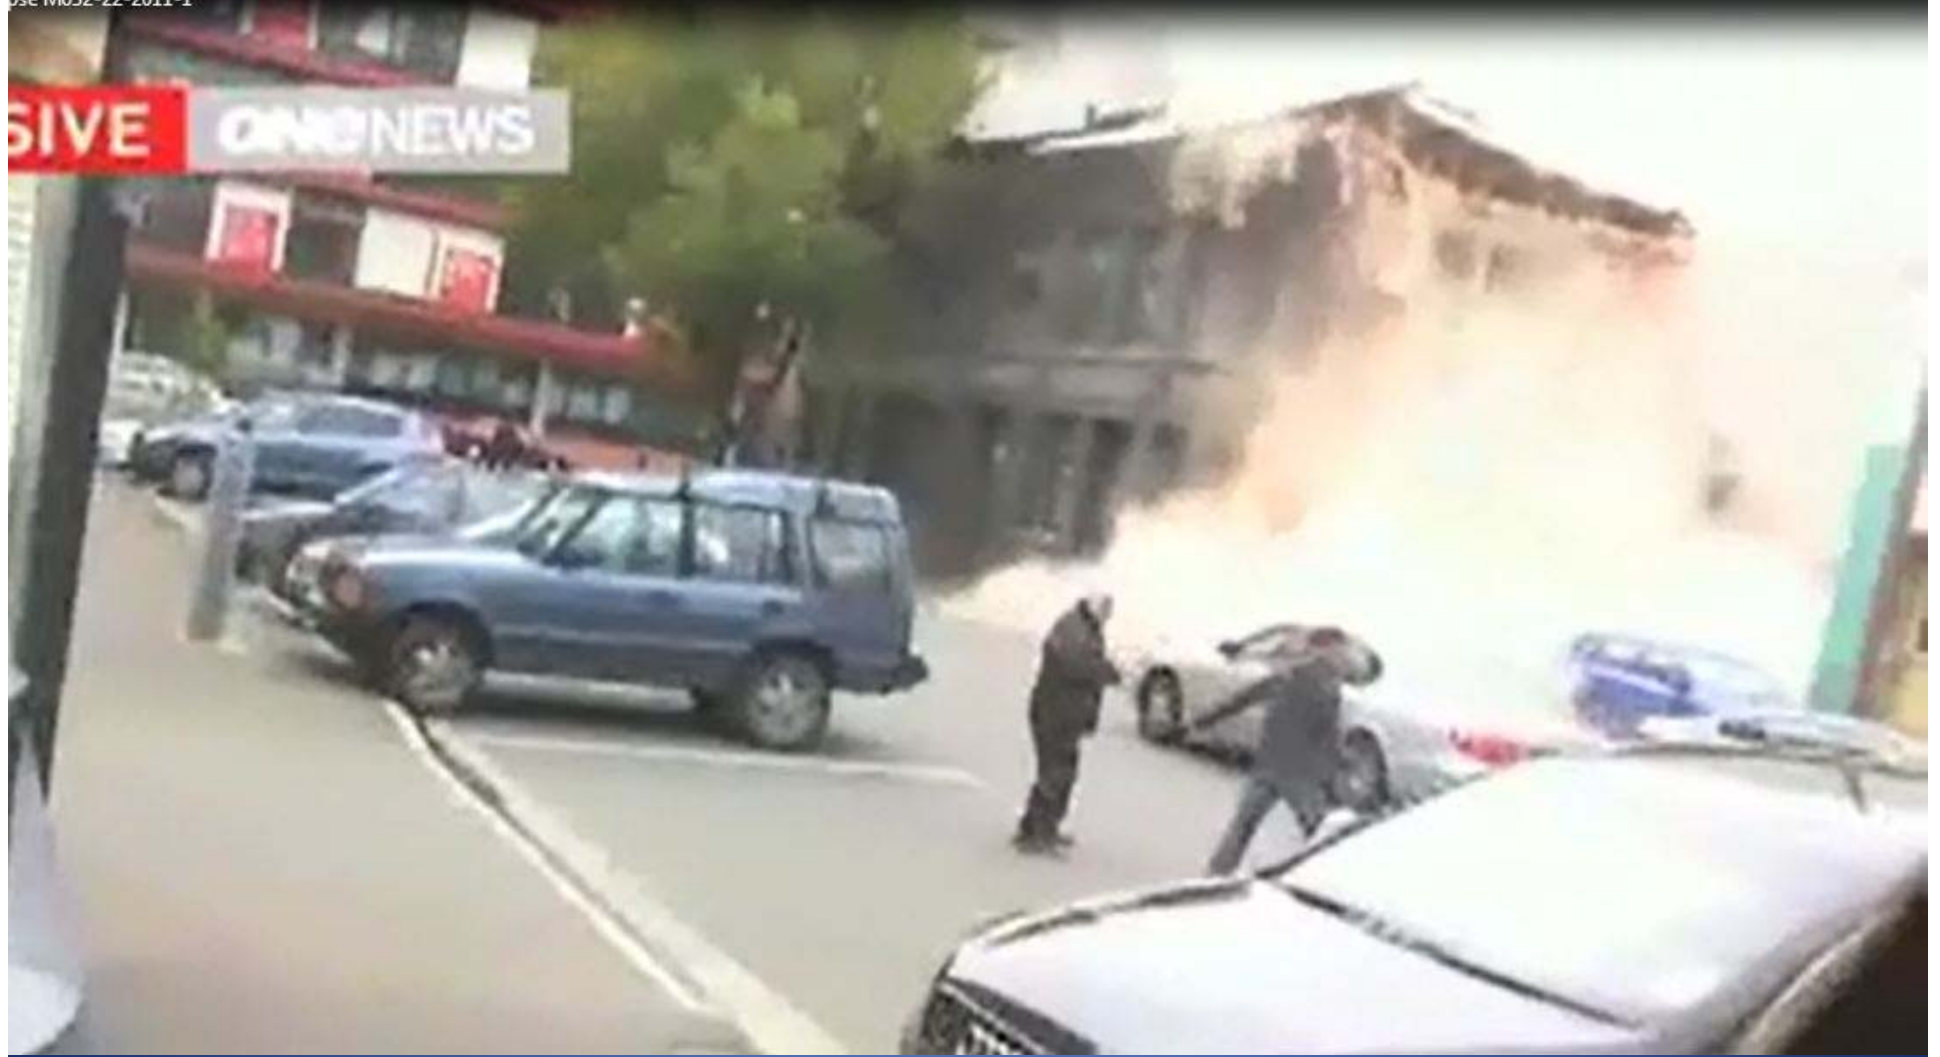
Upper part of left-facing wall is starting for fail and fall.
