# **Seismic Risk of Unreinforced Masonry Buildings in Nevada**

**Craig M. dePolo**

**Nevada Bureau of Mines and Geology**

**October 16, 2019**

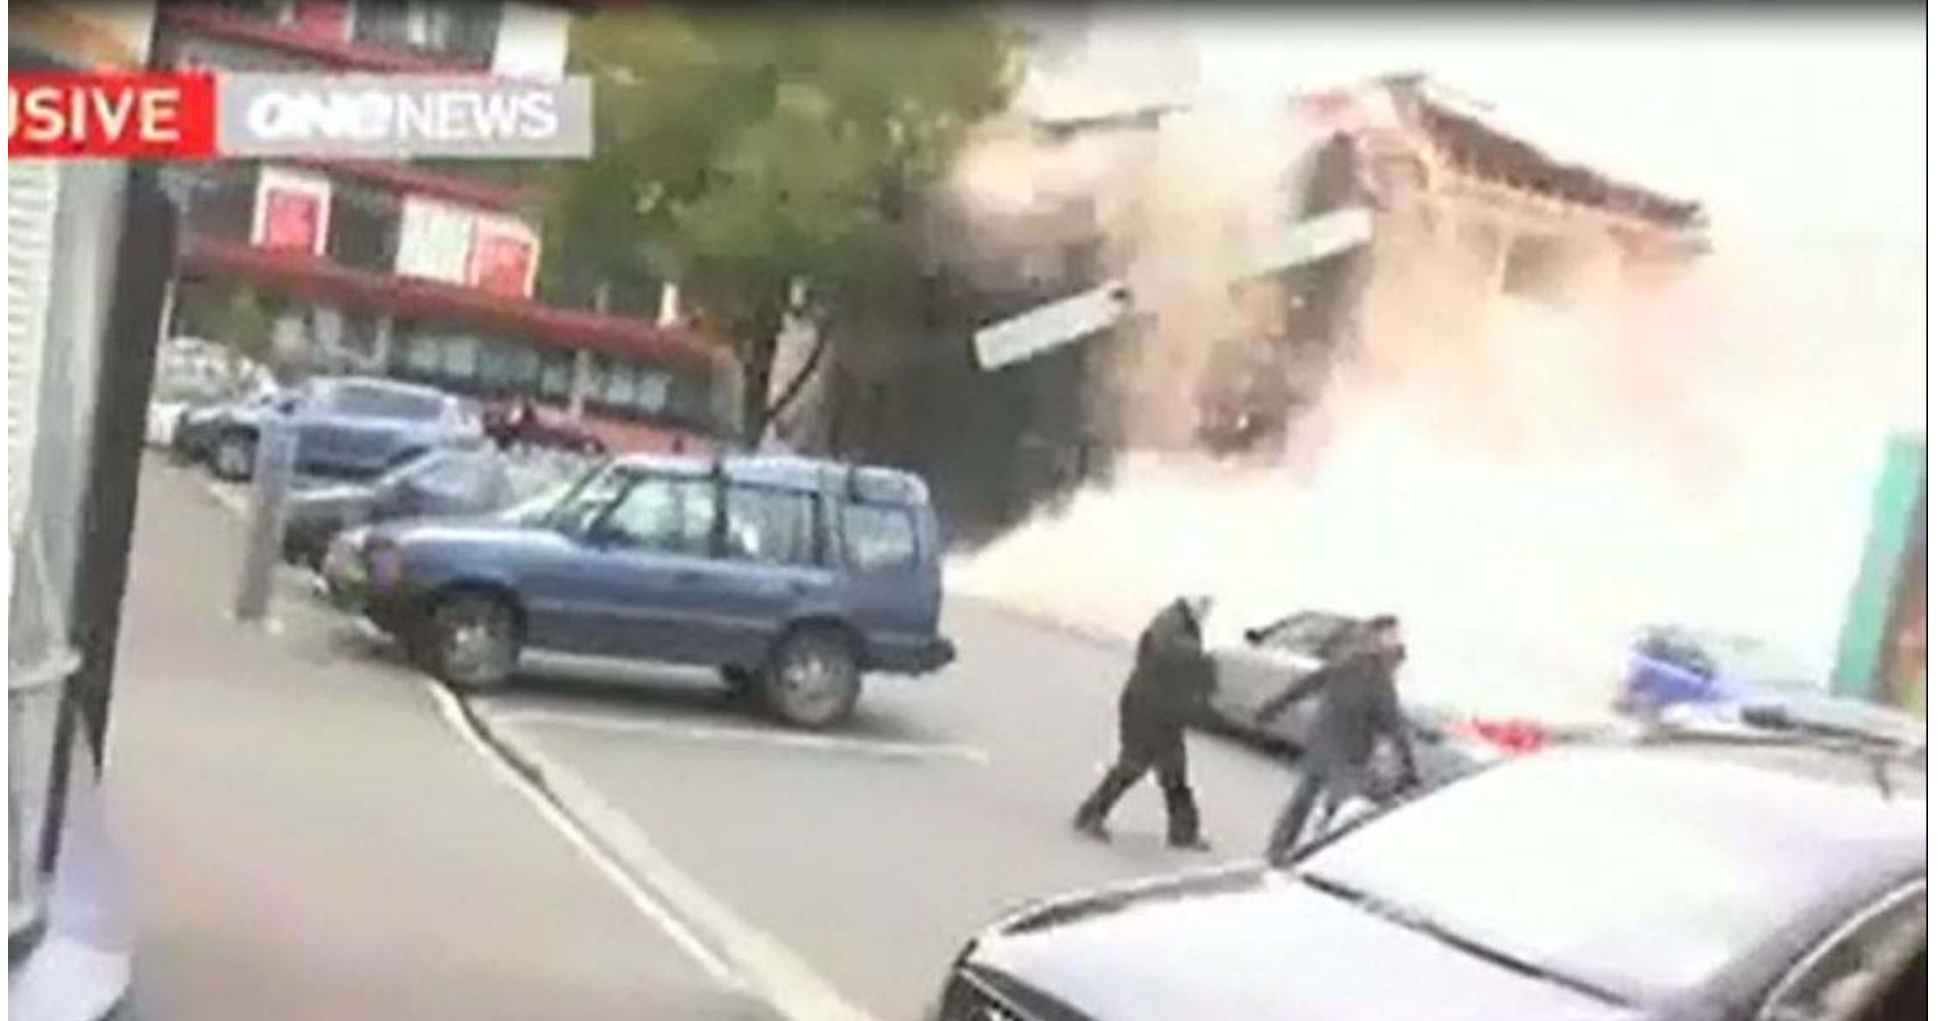
Large part of upper part of wall on the left-facing wall is falling off as more of the upper part of that wall fails.

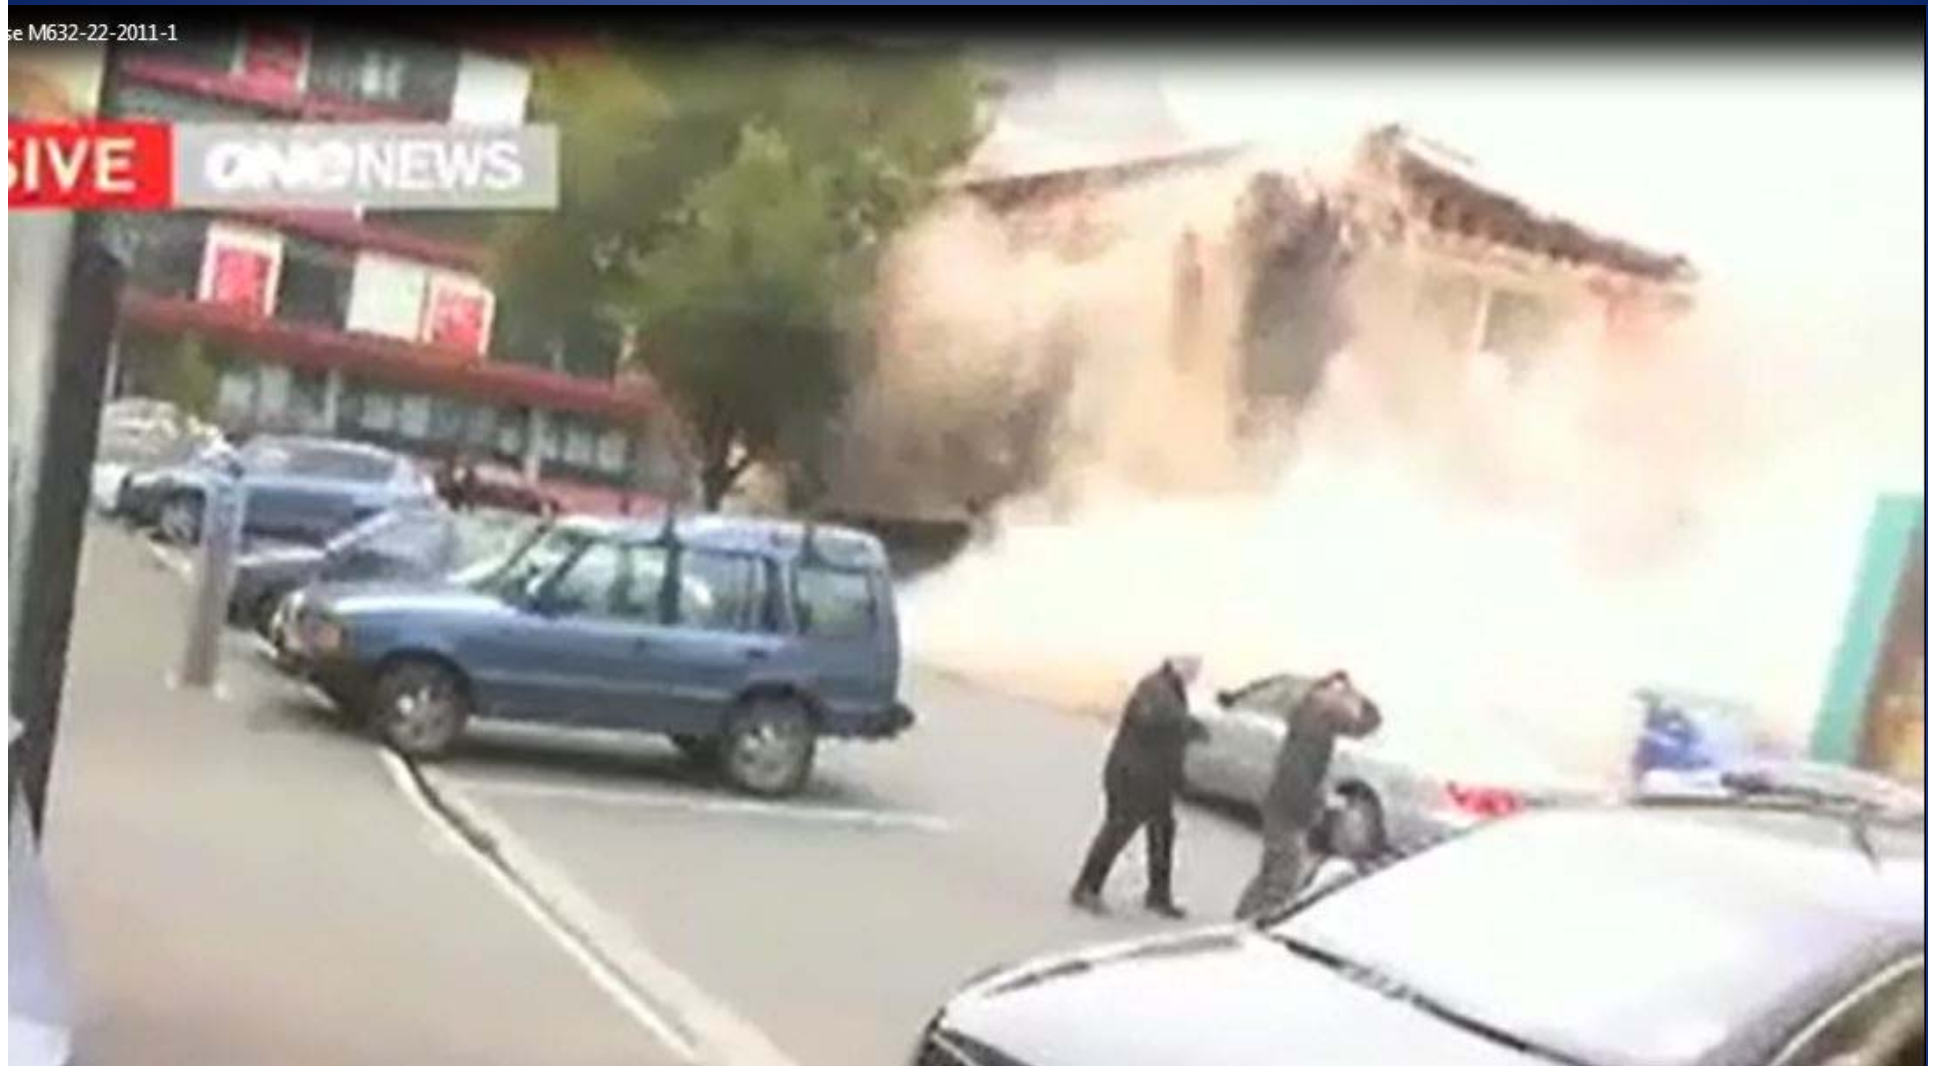
More of the upper part of the left-facing wall is failing in chunks.

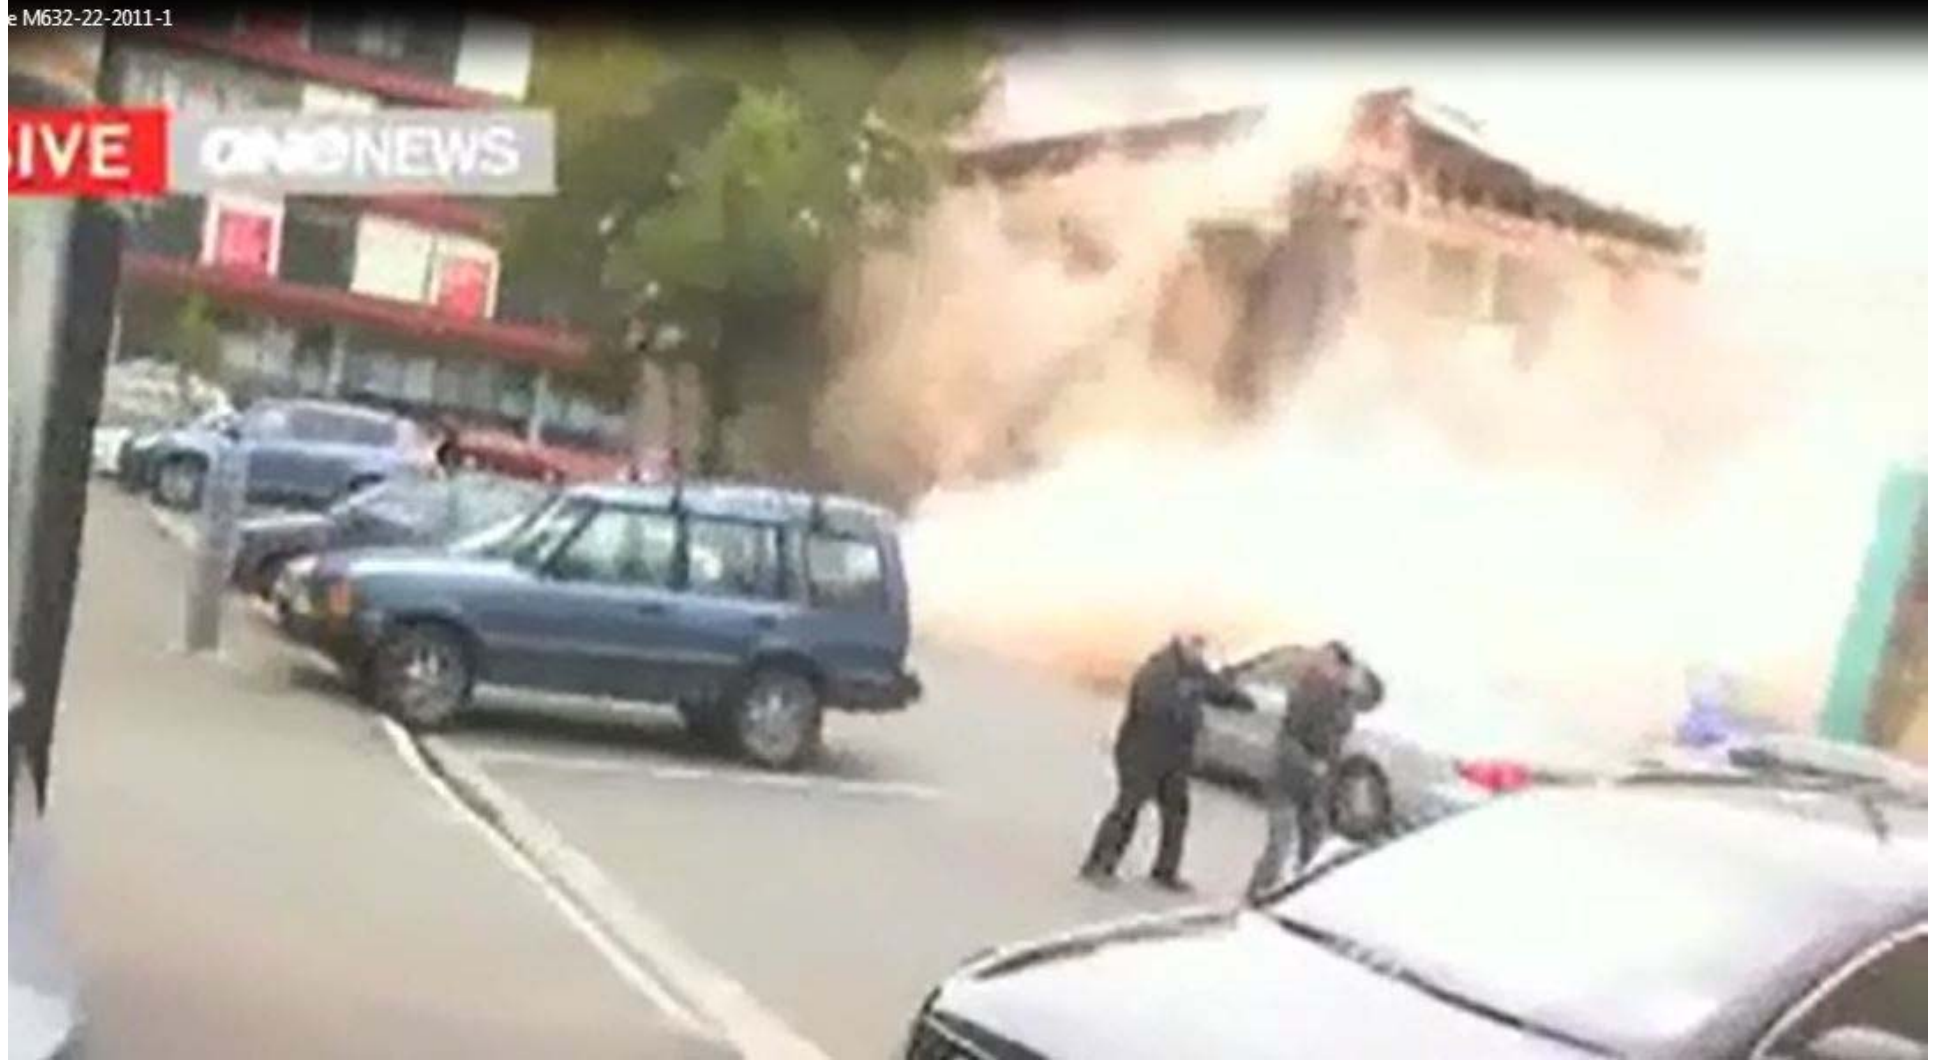
Continued failure of the upper part of the left-facing wall – chunks of Bricks continue to fall.

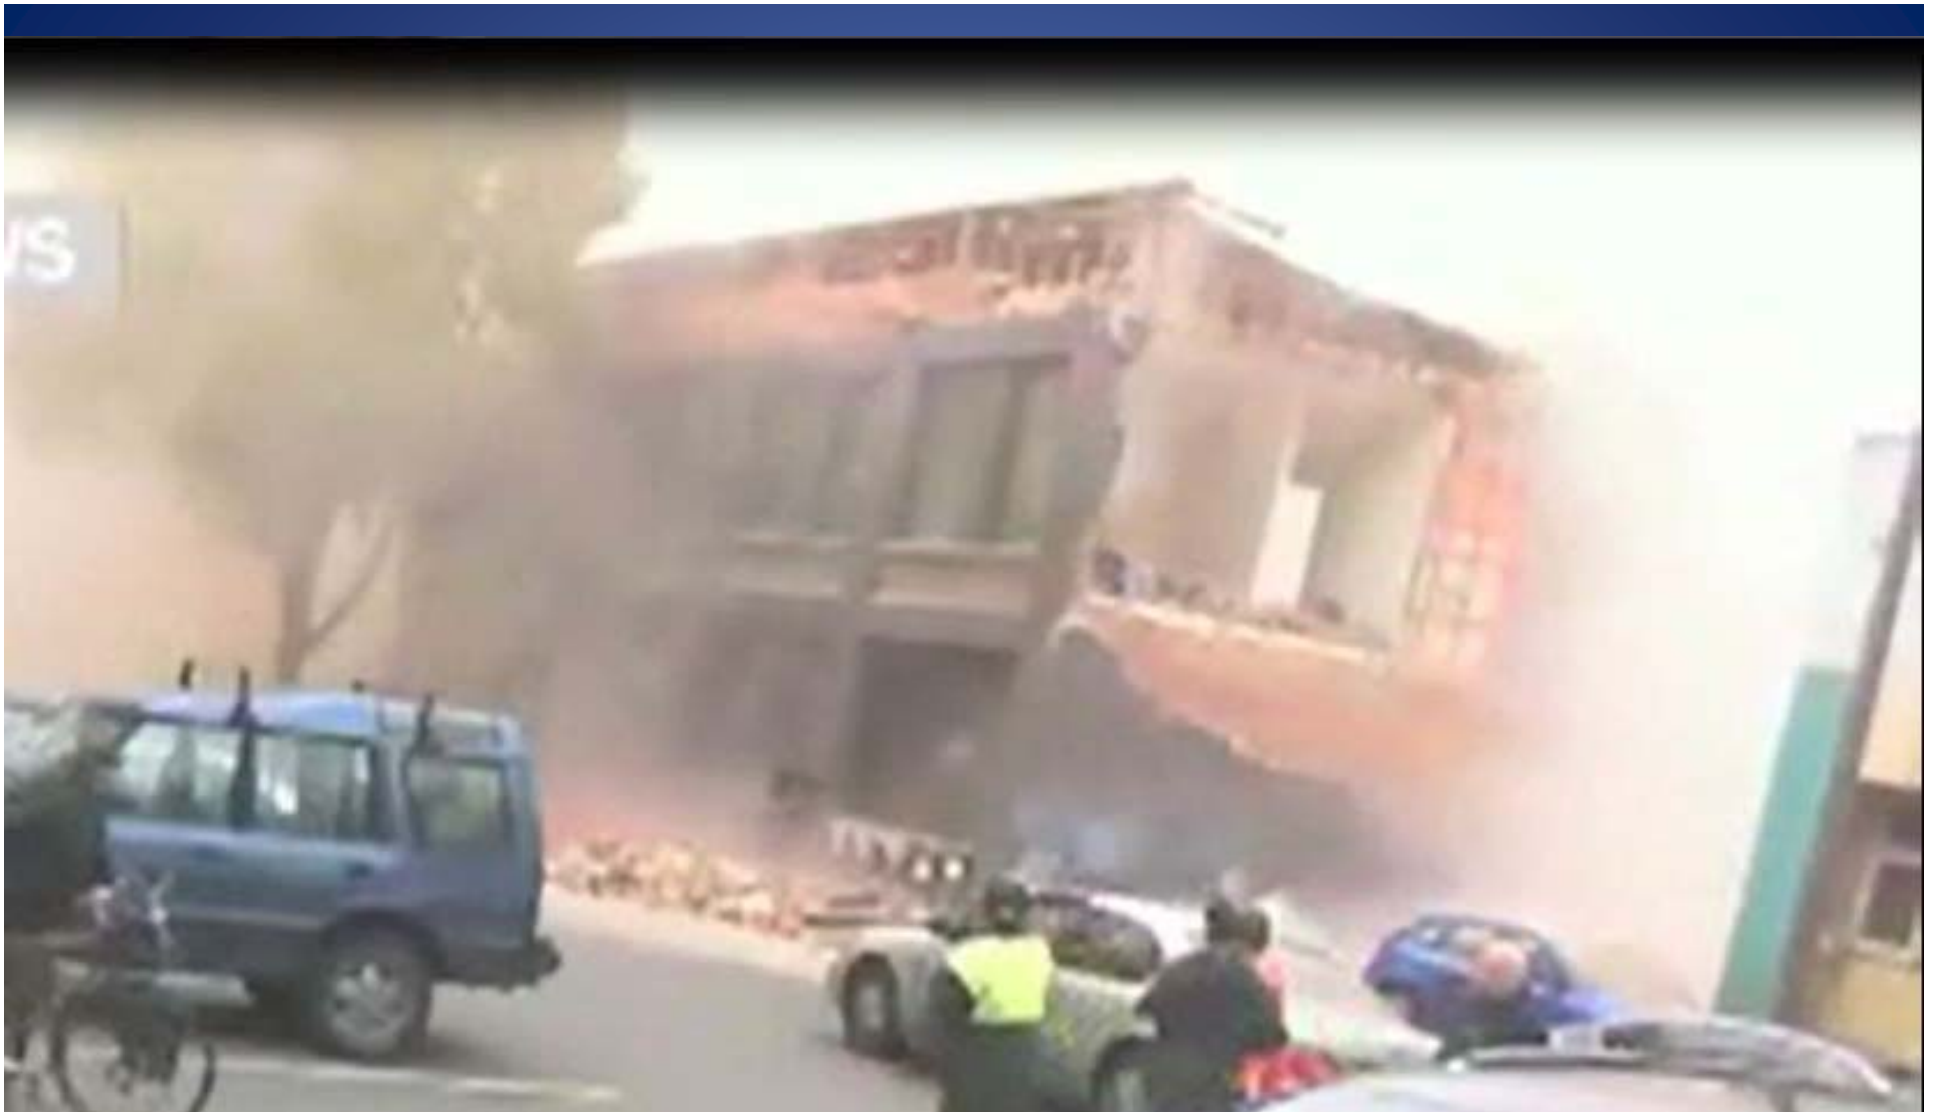
**Damaged URM – major failure of right facing wall exposing rooms and Failure of the upper part of the left facing wall. Debris surrounds building.**

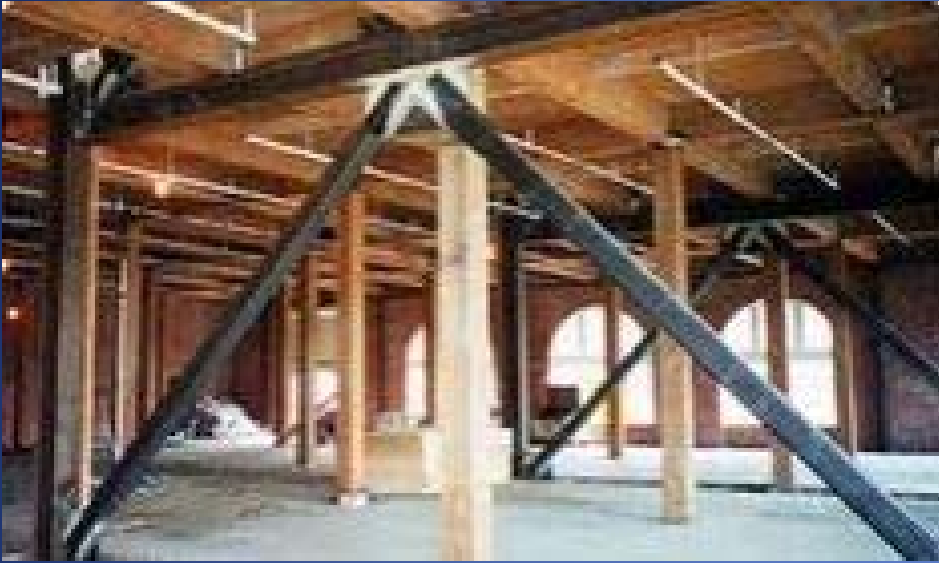
Interior cross bracing helps prevent building collapse

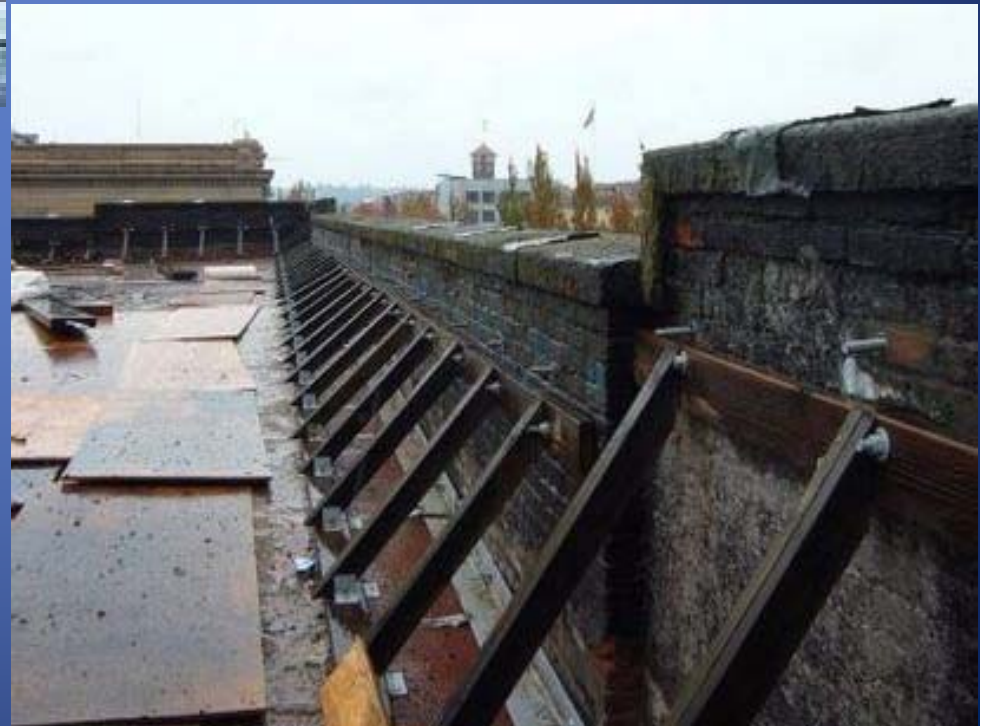
Bracing of URM parapets keeps them from toppling to the sidewalk below

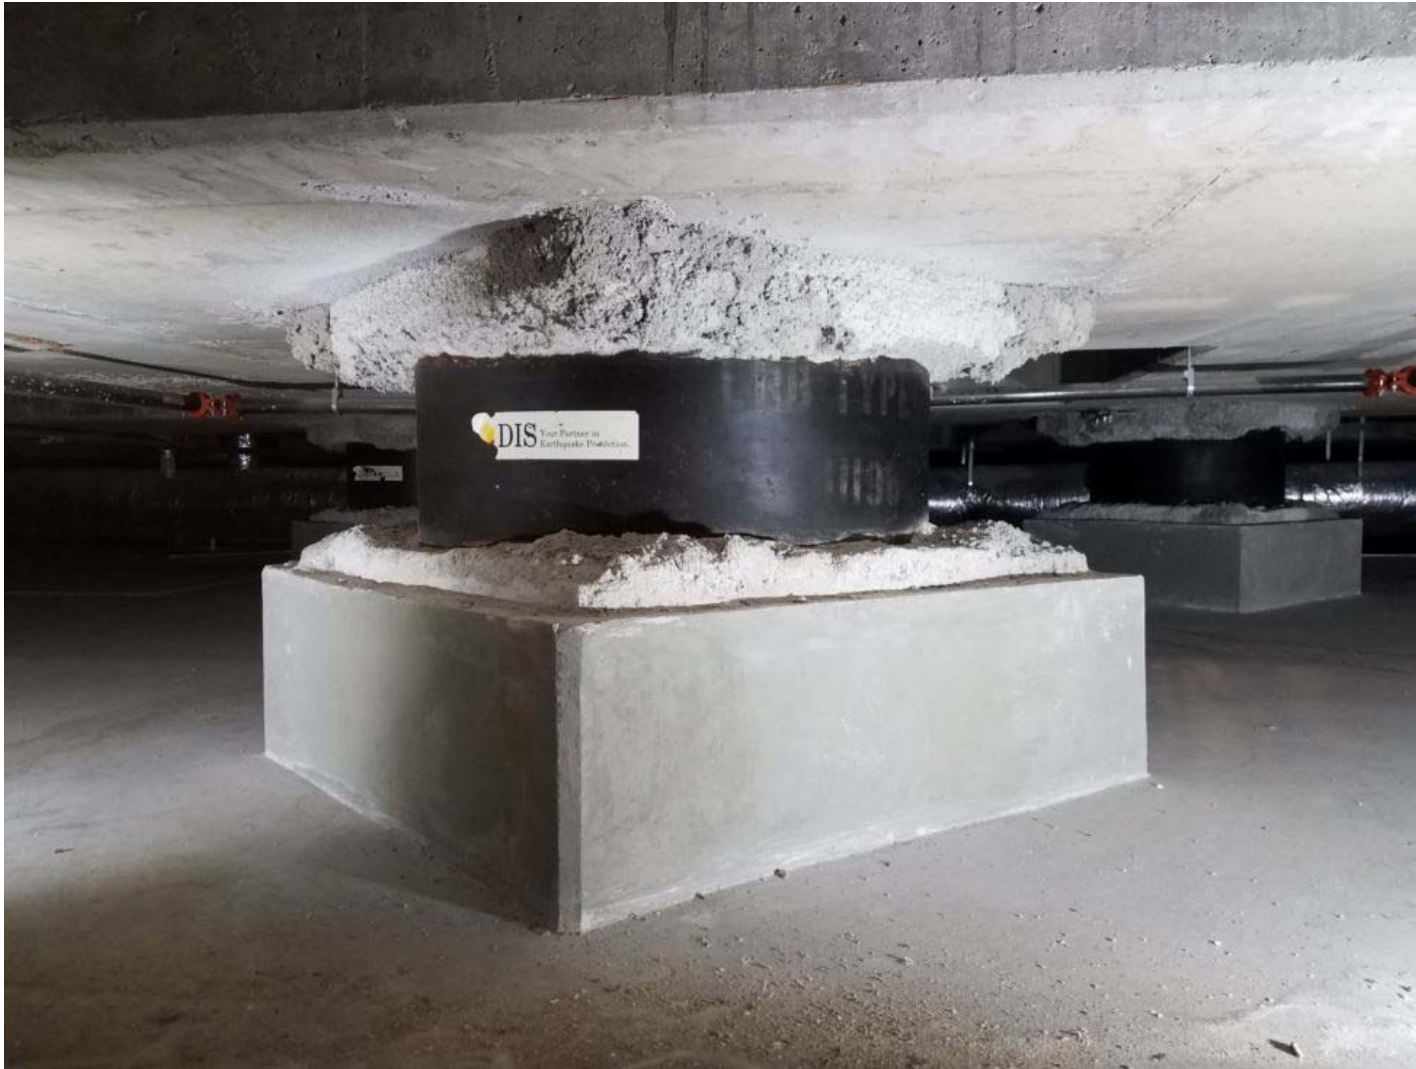
**Utah State Capitol – seismic strengthening and base isolation (above)**

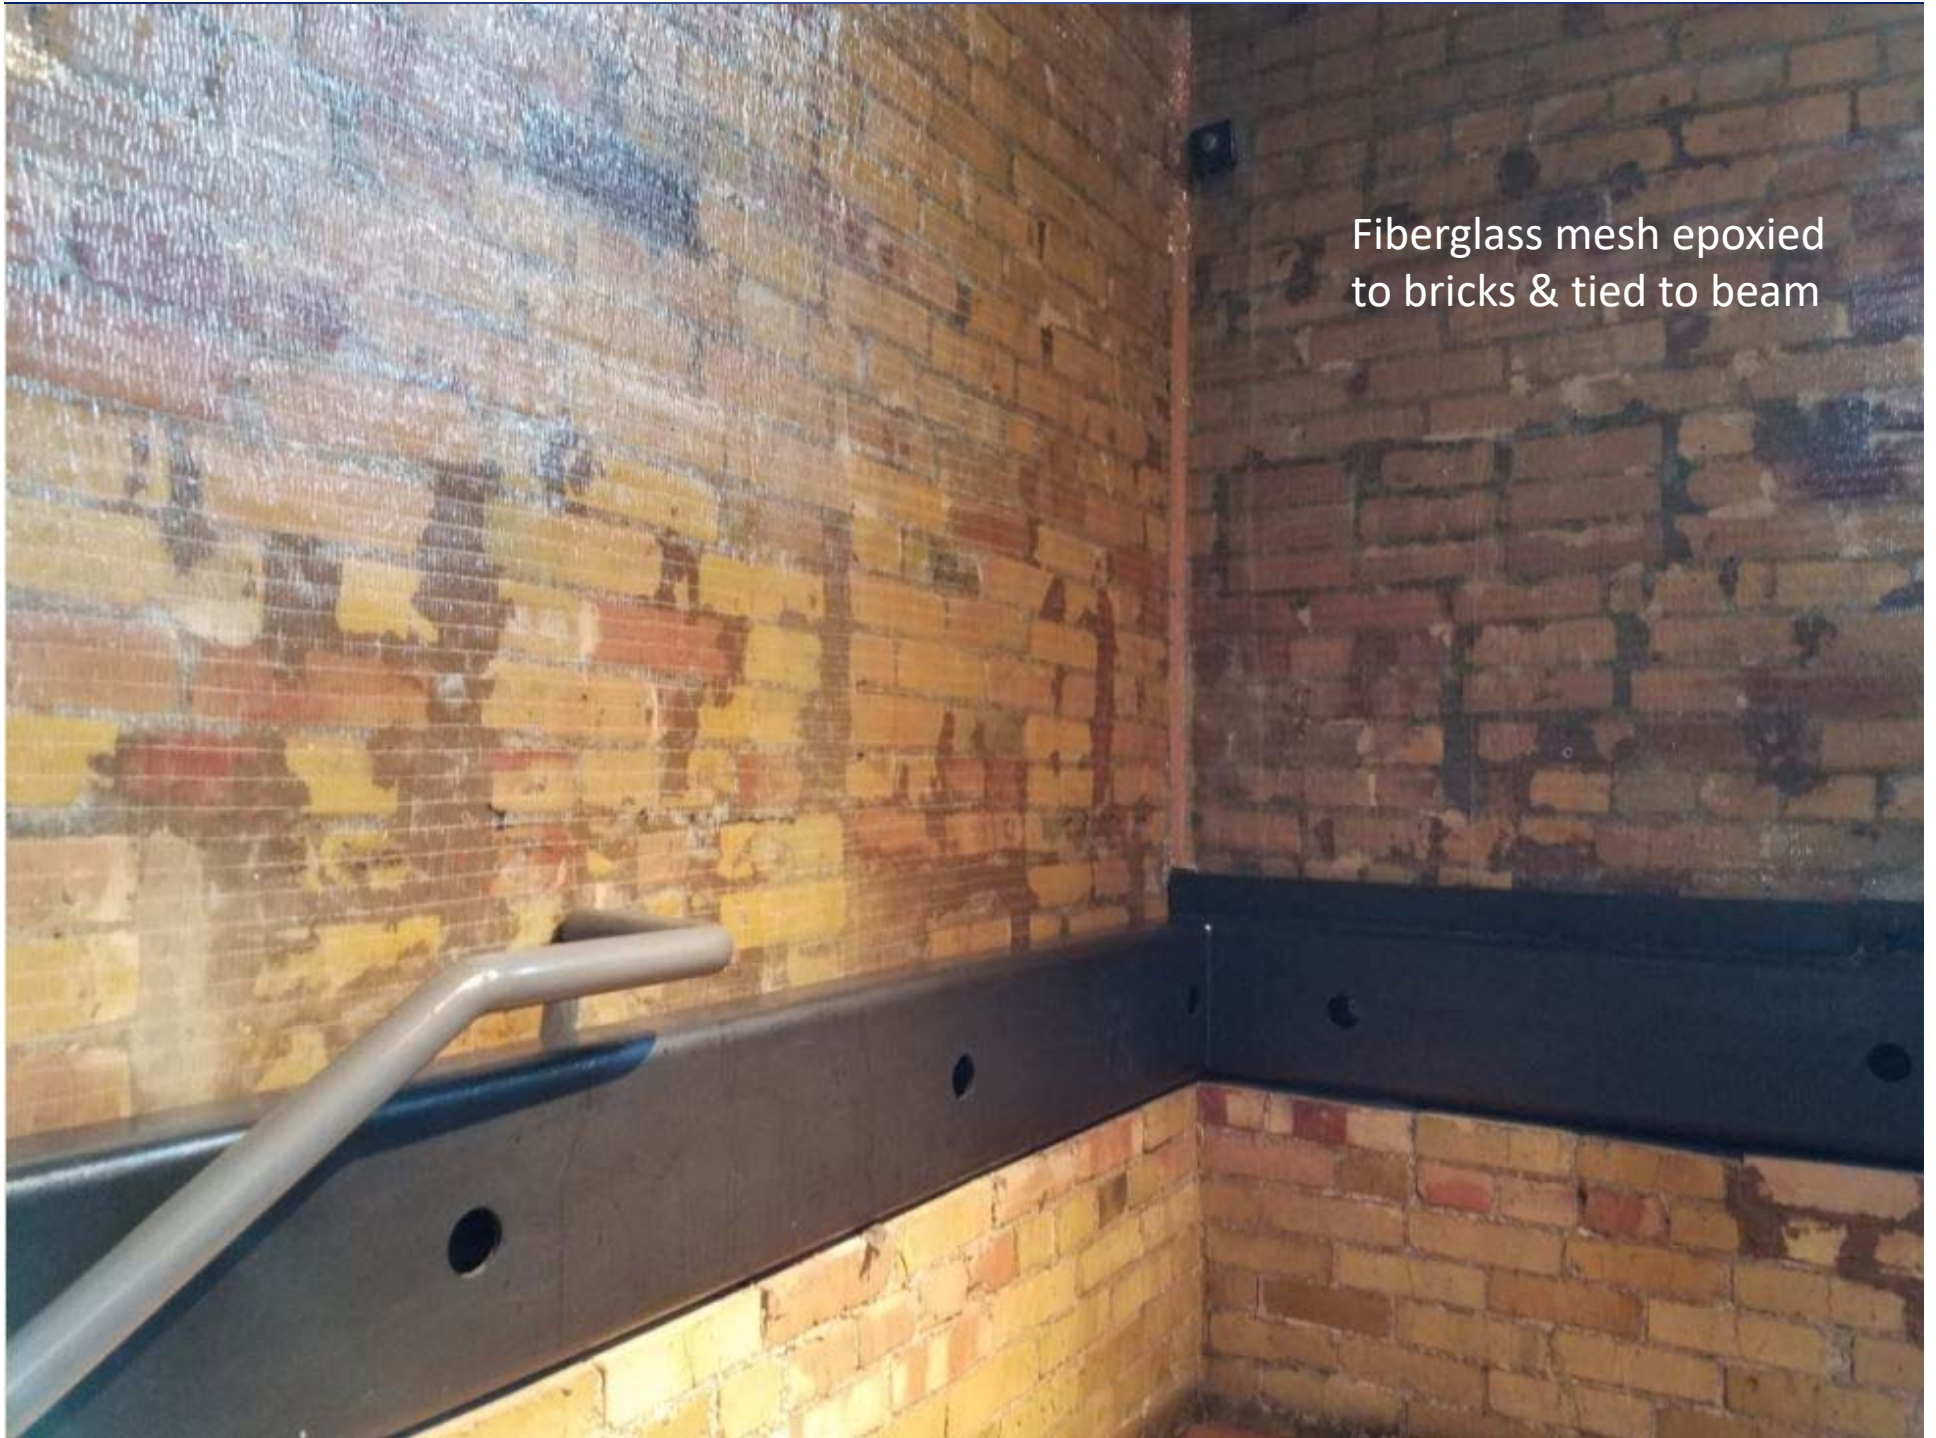
Fiberglass mesh epoxied  
to bricks & tied to beam
